IMPACTS OF DOCKS IN PENDER HARBOUR: PHASE 2 ASSESSMENT

MARCH 2018

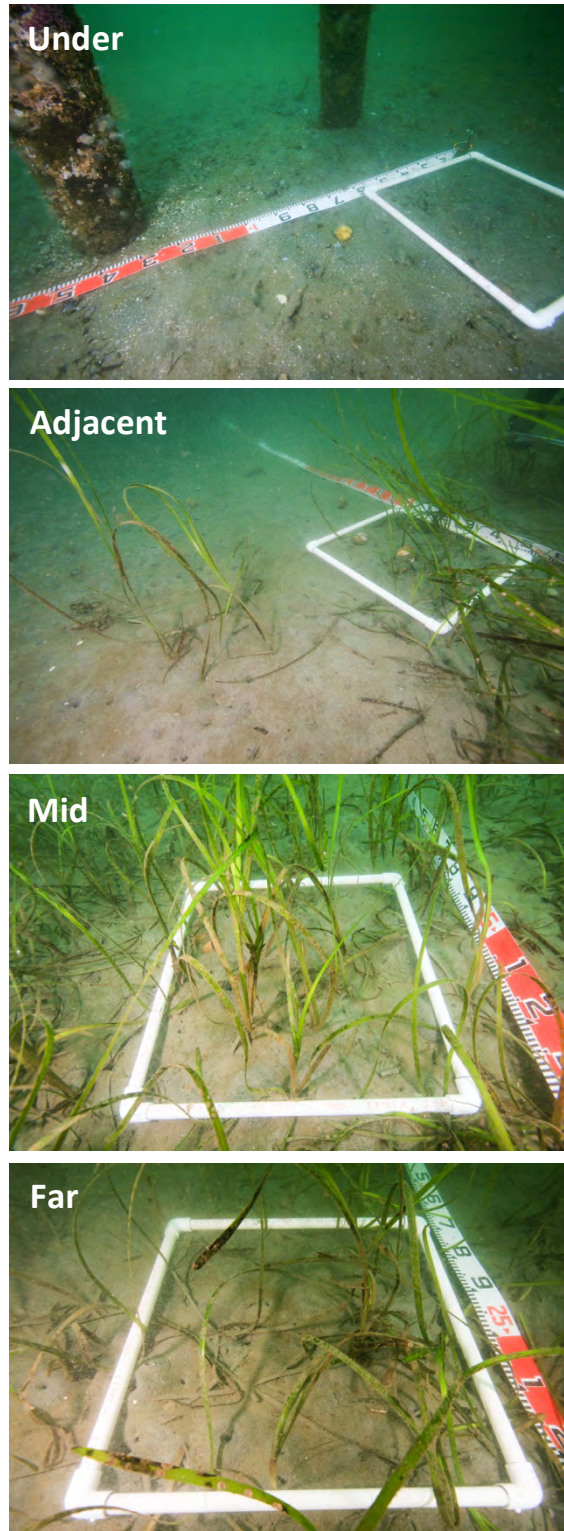
Figure 18. Example of the effects of dock shading on eelgrass growth. Photos of the Under, Adjacent, Mid, and Far quadrats along Transect EG4. Eelgrass growth stops short of the dock due to inadequate light penetration.

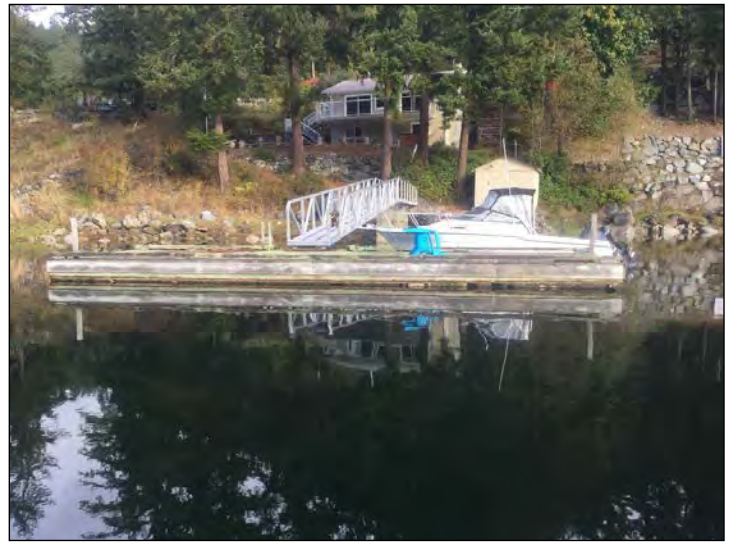
Photo: 20
North shore of Gunboat Bay. Typical wood dock with styrofoam floats.
(Latitude: 49°37'43.55", Longitude: -124°0'17.46", Date Taken:
October-11-17 9:35:55 AM)

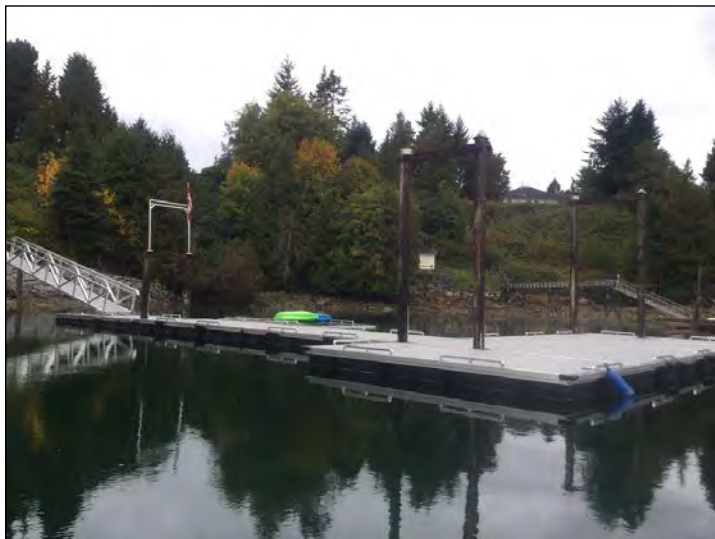
Photo: 161
 West shore of Bargain Bay. Eelgrass bed growing around newer dock. Based on 2014 orthophotographs, the newer dock replaced an old dock.
 (Latitude: 49°36'48.14", Longitude: -124°2'28.49", Date Taken: October-12-17 8:43:25 AM)

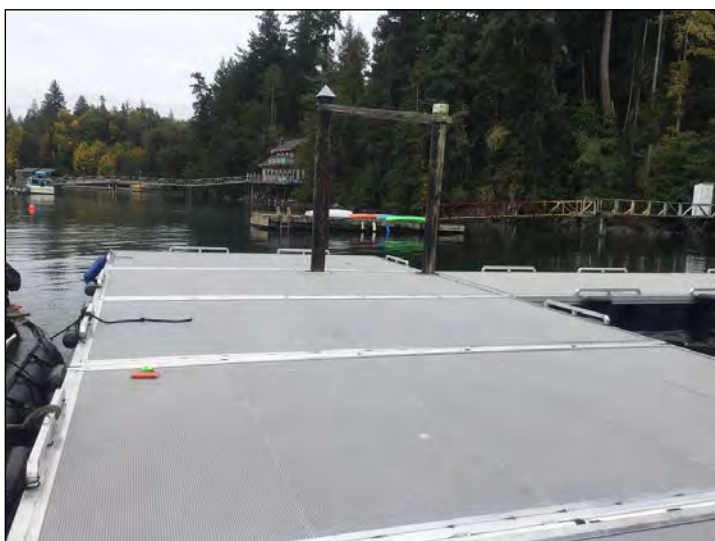
Photo: 80
Location of eelgrass transect EG3. Eelgrass growing around but not under dock. This newer dock has concrete decking with holes, and has replaced the old dock shown in 2014 orthophotographs. New dock has a larger footprint than old dock.
(Latitude: 49°36'48.50", Longitude: -124°2'28.68")

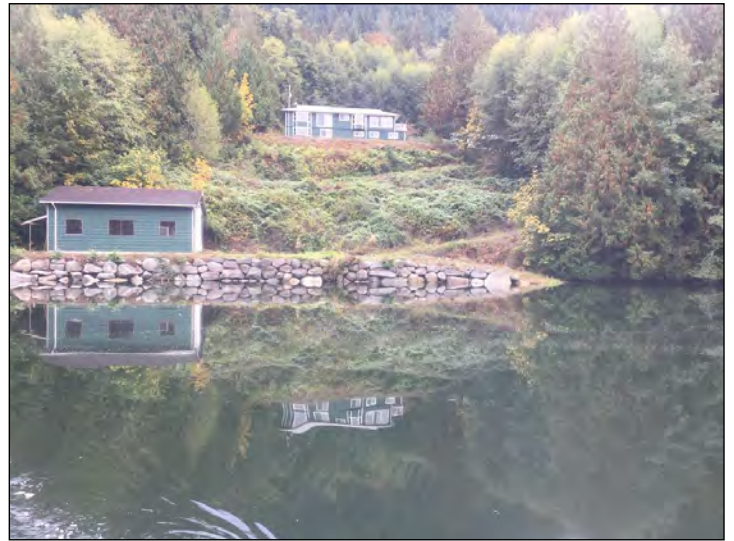
Photo: 2
South shore of Gunboat Bay. Human-altered foreshore.
(Date Taken: October-11-17 11:38:16 AM, Latitude:
49°37'33.66", Longitude: -124°0'33.97")

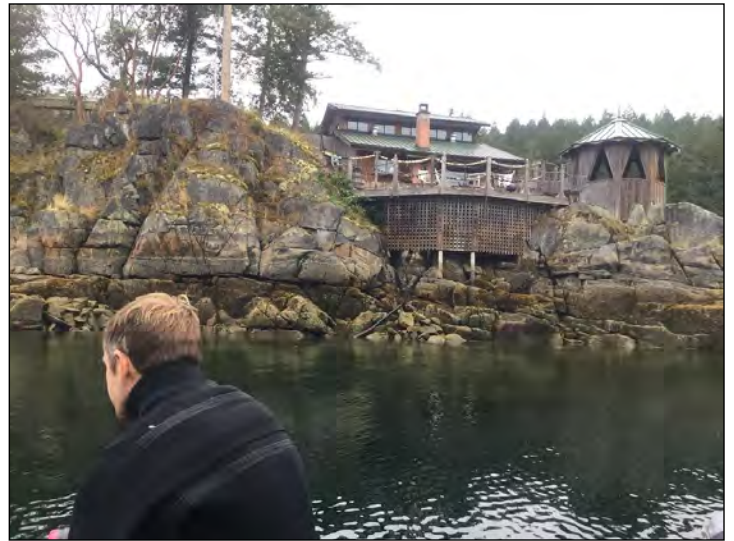
Photo: 6
Example of a possible private outfall pipe on Trinity Island in Gerrans Bay.
(Date Taken: October-16-17 8:46:55 AM, Latitude: 49°37'21.03", Longitude: -124°2'27.07")
