IMPACTS OF DOCKS IN PENDER HARBOUR: PHASE 2 ASSESSMENT

MARCH 2018

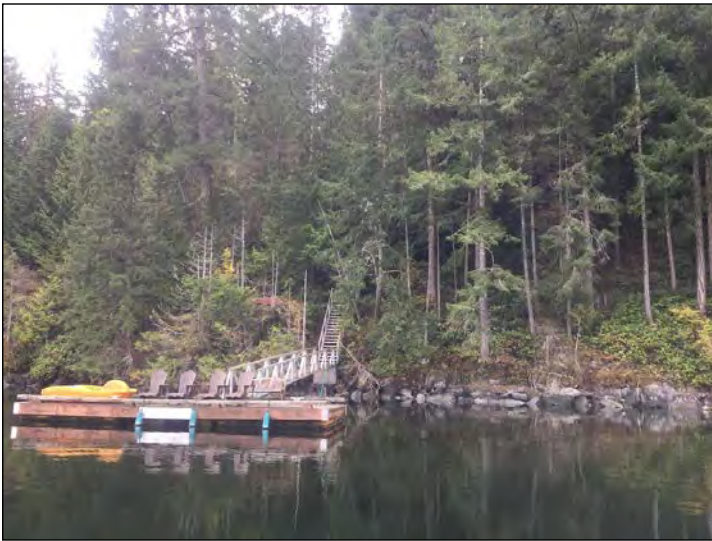
Photo: 68
Wood dock with styrofoam floats just west of T16.
(Latitude: 49°37'36.36", Longitude: -123°59'58.51", Date Taken:
October-11-17 11:23:36 AM)

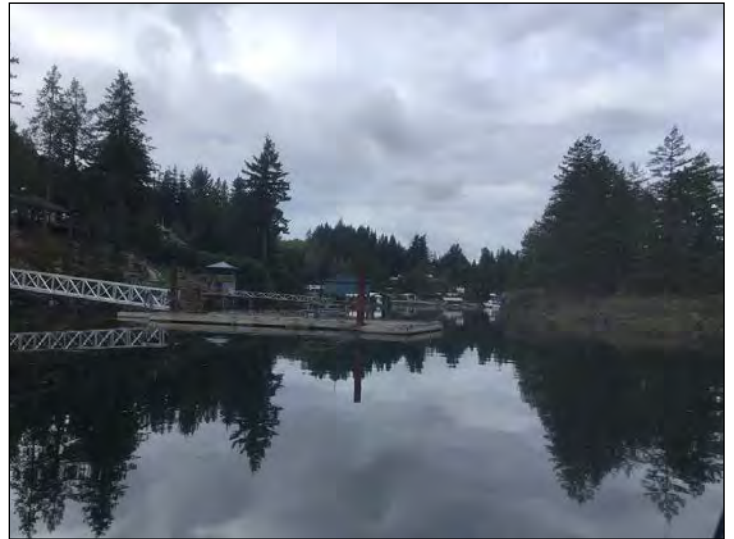
Photo: 71
Long ramps to docks along south shore of Gunboat Bay.
(Latitude: 49°37'35.86", Longitude: -124°0'11.88", Date Taken: October-11-17 11:30:48 AM)

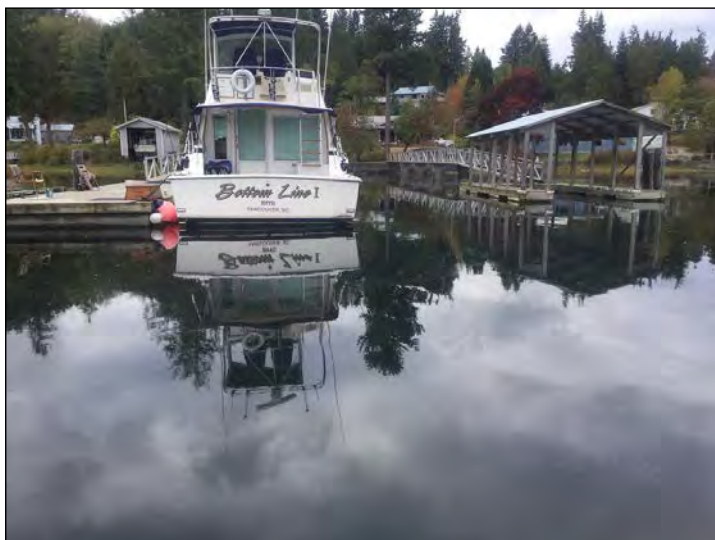
Photo: 78
South shore of Gunboat Bay. Long ramps to boathouse and
docks.
(Latitude: 49°37'35.41", Longitude: -124°0'32.15", Date Taken:
October-11-17 11:39:32 AM)

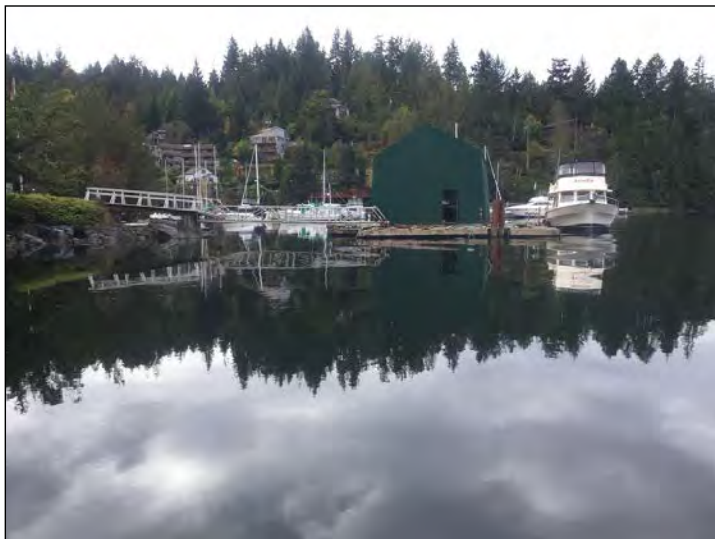
Photo: 85
Docks along south shore of Gunboat Bay. Old dock ramp fallen in water.
(Latitude: 49°37'36.46", Longitude: -124°0'55.68", Date Taken: October-11-17 11:47:58 AM)

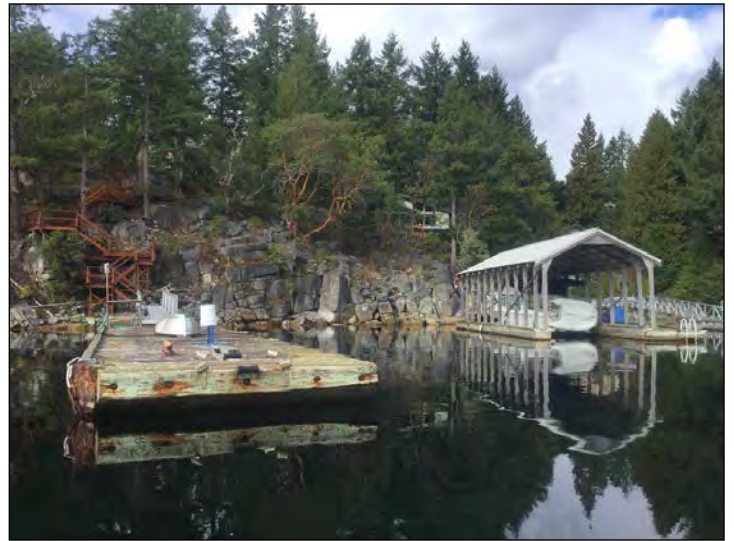
Photo: 93
Garden Peninsula shoreline between Hospital Bay and Garden Bay. Human-altered foreshore.
(Latitude: 49°37'39.78", Longitude: -124°1'50.24", Date Taken: October-11-17 12:26:15 PM)

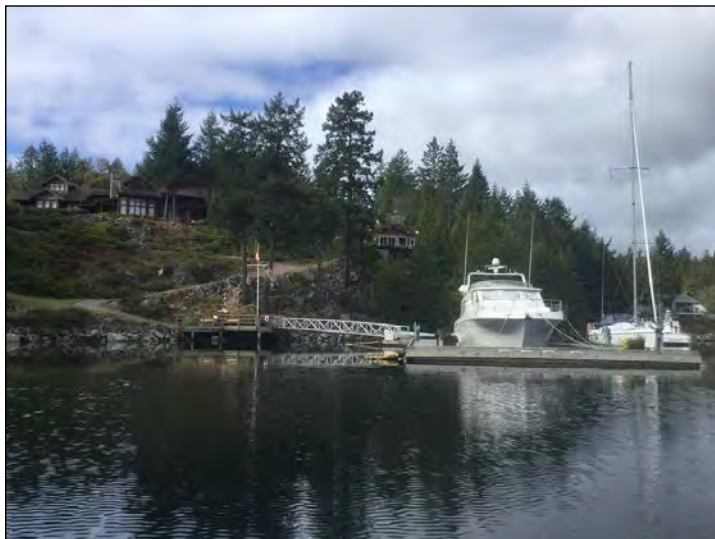
Photo: 96
Southwest Garden Bay. Human-altered foreshore.
(Latitude: 49°37'47.61", Longitude: -124°1'30.72", Date Taken: October-11-17 12:35:23 PM)

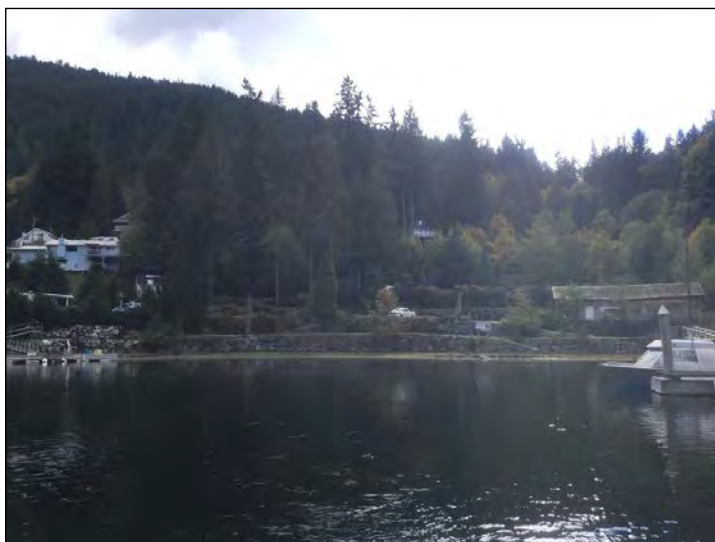
Photo: 107
End of Wilkinson Cove. Human-altered shoreline.
(Latitude: 49°37'29.89", Longitude: -124°1'3.15", Date Taken:
October-11-17 1:00:47 PM)

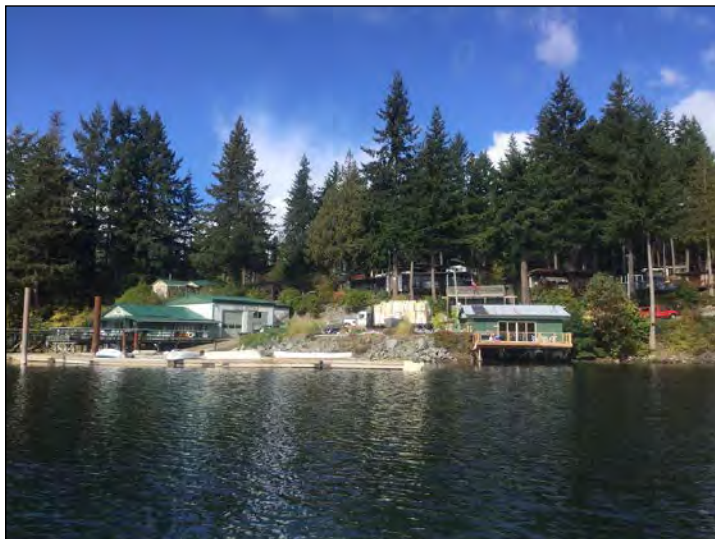
Photo: 121
Coho Marina Resort. Truck with styrofoam blocks for docks.
(Latitude: 49°37'12.09", Longitude: -124°1'50.59", Date Taken:
October-11-17 1:38:08 PM)

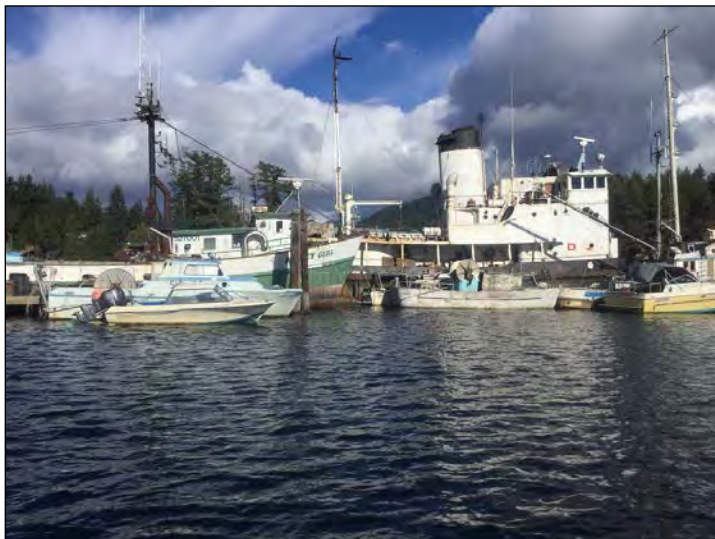
Photo: 142
West shore of Gerrans Bay, north of T23. Collection of old boats.
(Latitude: 49°37'16.97", Longitude: -124°2'31.57", Date Taken:
October-11-17 2:13:42 PM)

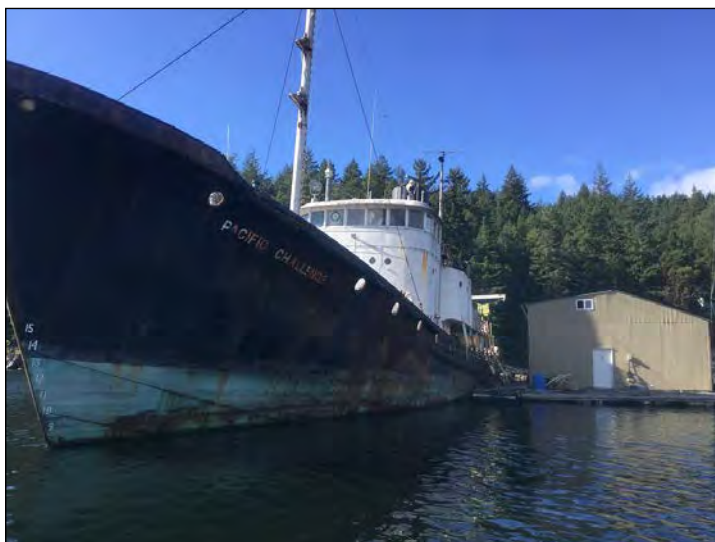
Photo: 143
West shore of Gerrans Bay. Collection of old boats.
(Latitude: 49°37'17.36", Longitude: -124°2'28.19", Date Taken:
October-11-17 2:14:59 PM)

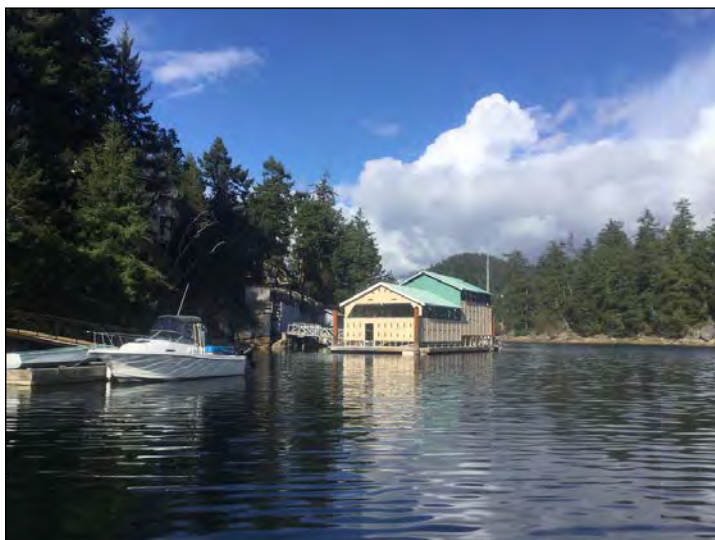
Photo: 147
West shore of Gerrans Bay across from Calder Island.
(Latitude: 49°37'27.27", Longitude: -124°2'22.35", Date Taken: October-11-17 2:22:53 PM)

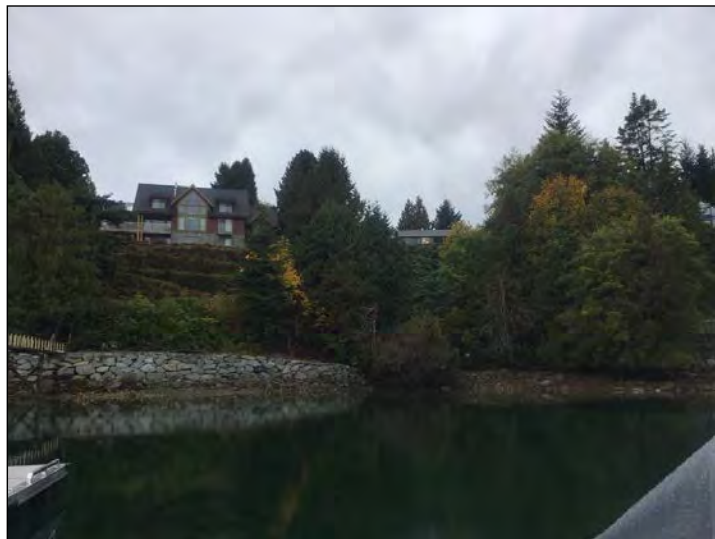
Photo: 162
 Small patchy eelgrass bed observed between docks in Bargain Bay.
 (Latitude: 49°36'48.99", Longitude: -124°2'28.56", Date Taken: October-12-17 8:44:10 AM)

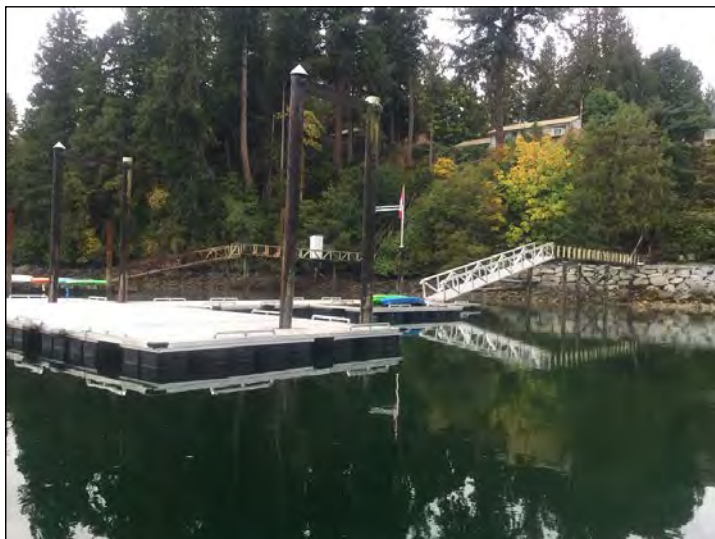
Photo: 163
 West shore of Bargain Bay. Eelgrass bed growing around dock.
 (Latitude: 49°36'49.05", Longitude: -124°2'28.50", Date Taken: October-12-17 8:46:24 AM)

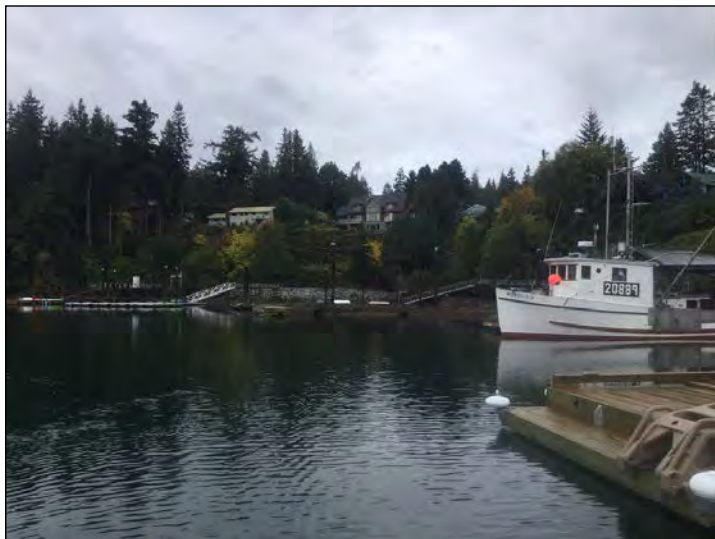
Photo: 165
Patchy eelgrass between docks along west shore of Bargain Bay.
(Latitude: 49°36'50.82", Longitude: -124°2'24.82", Date Taken:
October-12-17 8:50:28 AM)

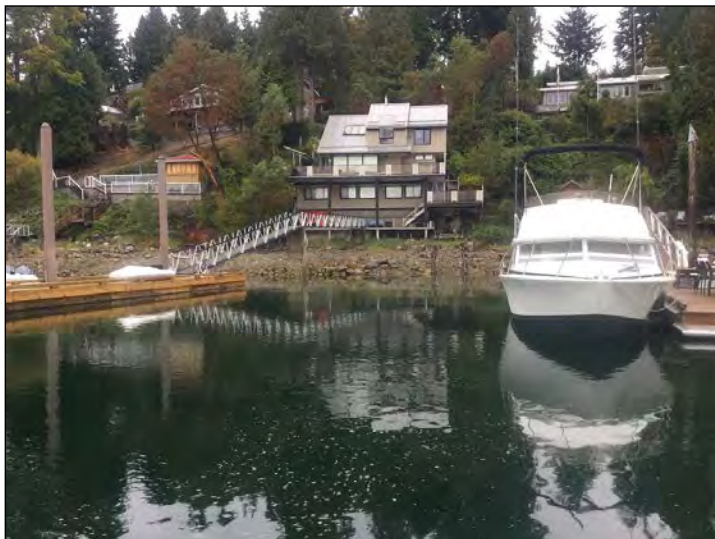
Photo: 166
Eelgrass continues around docks along west shore of Bargain Bay.
(Latitude: 49°36'52.10", Longitude: -124°2'23.56", Date Taken:
October-12-17 8:54:11 AM)

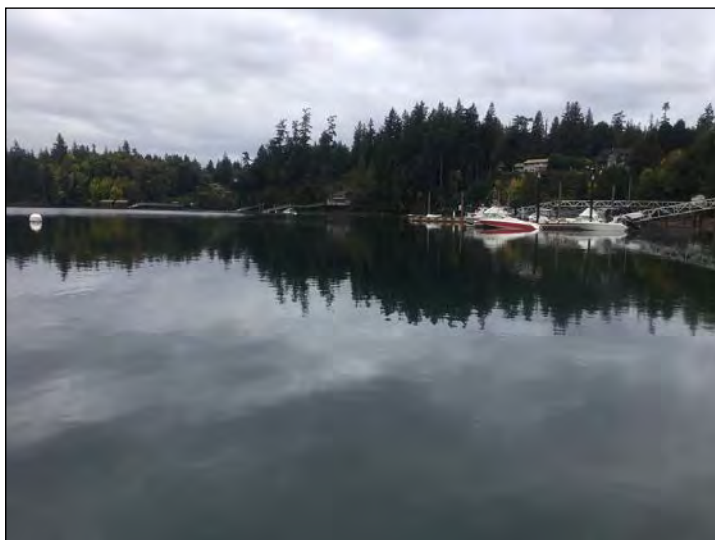
Photo: 167
Subtidal eelgrass along west shore of Bargain Bay. Facing south
towards west shore.
(Latitude: 49°36'54.19", Longitude: -124°2'20.57", Date Taken:
October-12-17 8:56:38 AM)

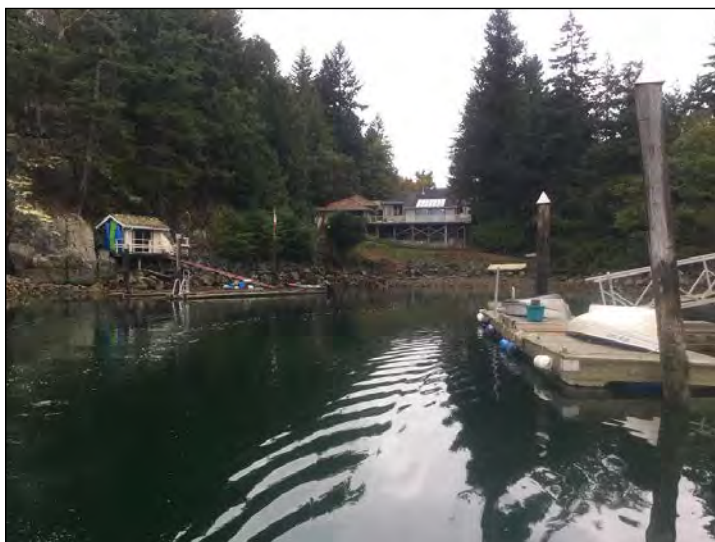
Photo: 171
Patchy eelgrass throughout the northwest end of Bargain Bay.
(Latitude: 49°36'59.64", Longitude: -124°2'16.91", Date Taken:
October-12-17 9:04:18 AM)

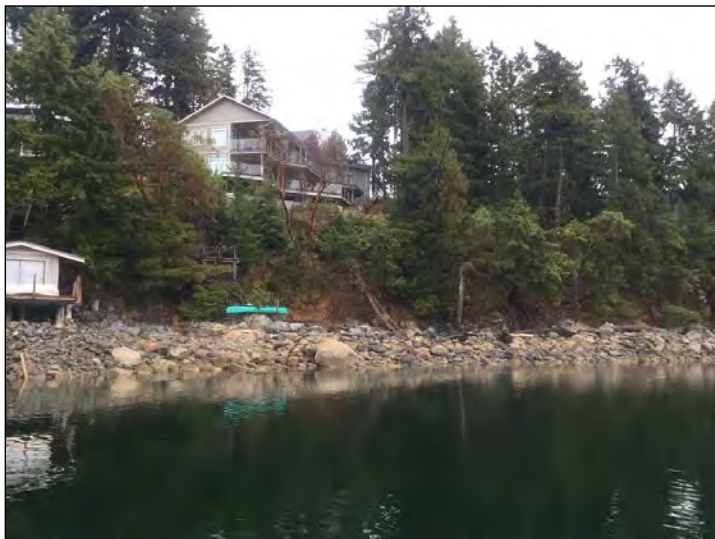
Photo: 178
East shore of Bargain Bay. Cobble and boulder shoreline.
(Latitude: 49°36'41.14", Longitude: -124°2'14.55", Date Taken:
October-12-17 9:18:21 AM)

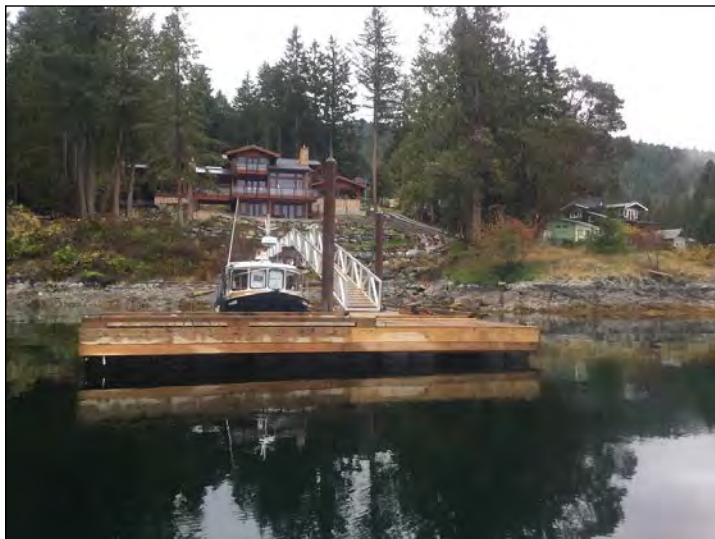
Photo: 185
New dock with plastic floats, across from northeast end of Edgecomb Island.
(Latitude: 49°36'32.83", Longitude: -124°1'45.33", Date Taken: October-12-17 9:29:59 AM)

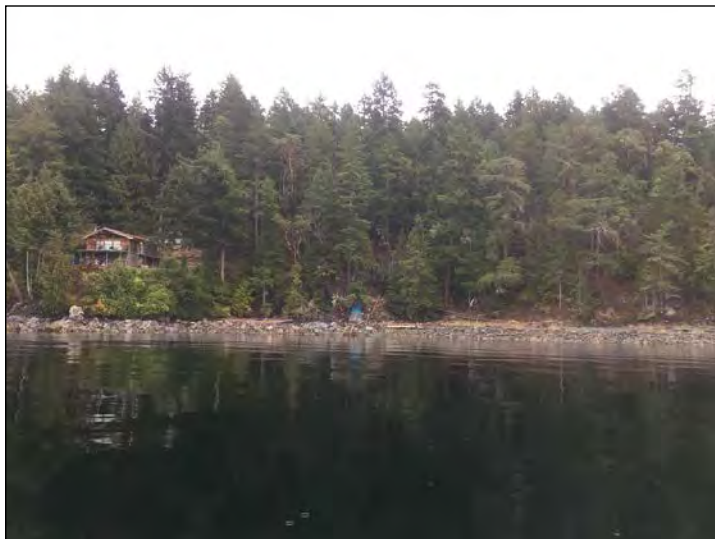
Photo: 192
Backshore of T36. Mature coniferous forest. One house with no dock.
(Latitude: 49°36'15.79", Longitude: -124°1'34.70", Date Taken:
October-12-17 9:39:03 AM)

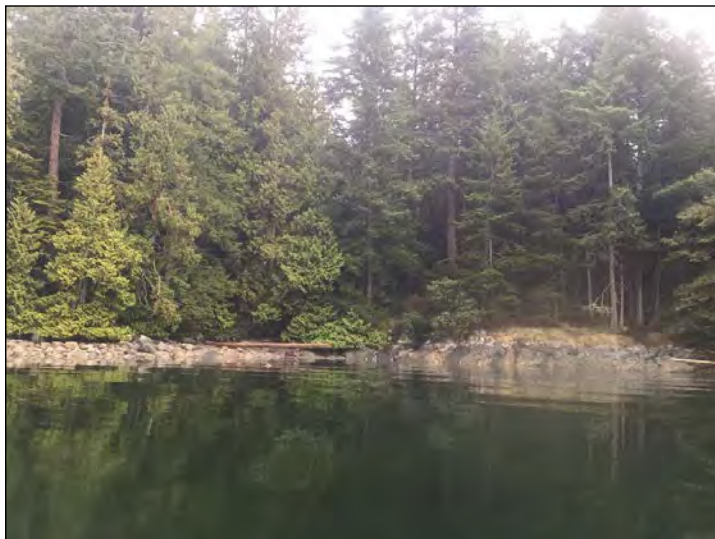
Photo: 208
Backshore looking west from along T30, located in Middle Bay.
An eelgrass bed is located in this bay.
(Latitude: 49°36'39.04", Longitude: -124°3'30.55", Date Taken:
October-12-17 10:09:55 AM)

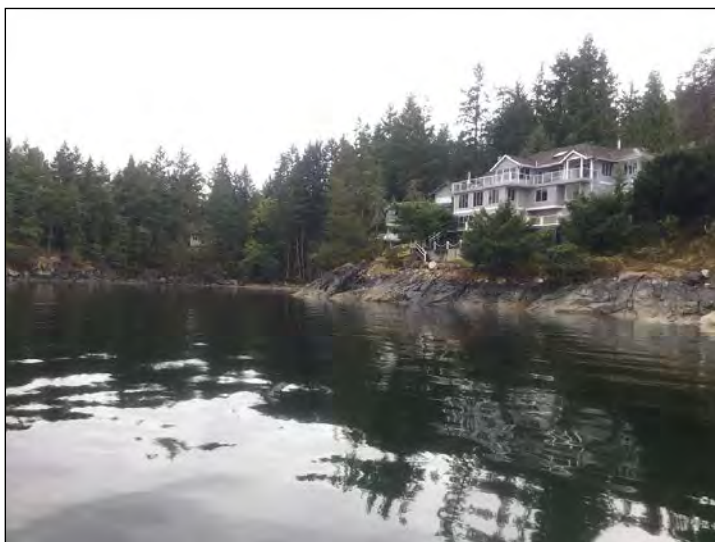
Photo: 215
Dock that can be lowered or elevated by a crane. West shore of
Francis Peninsula, just north of Moore Point.
(Latitude: 49°37'8.04", Longitude: -124°3'50.39", Date Taken:
October-12-17 10:38:49 AM)

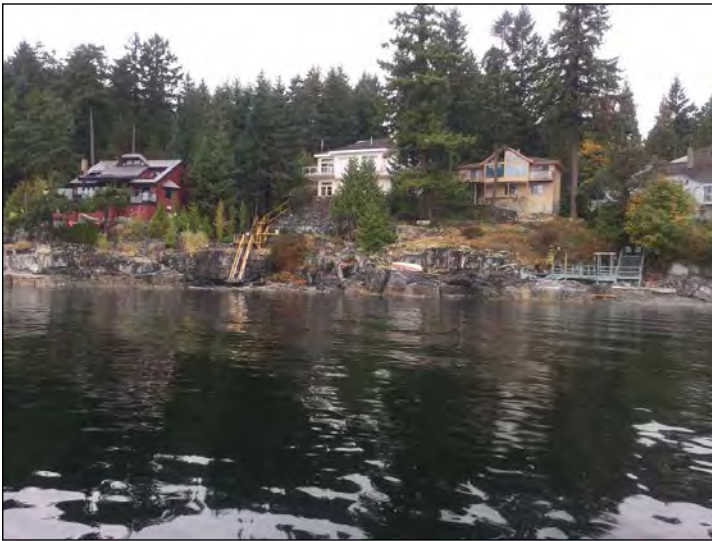
Photo: 220
Shoreline east of T1. New dock as of 2014 orthophotographs.
Blue heron was observed on dock railing.
(Latitude: 49°38'18.93", Longitude: -124°4'3.68", Date Taken:
October-12-17 10:56:14 AM)

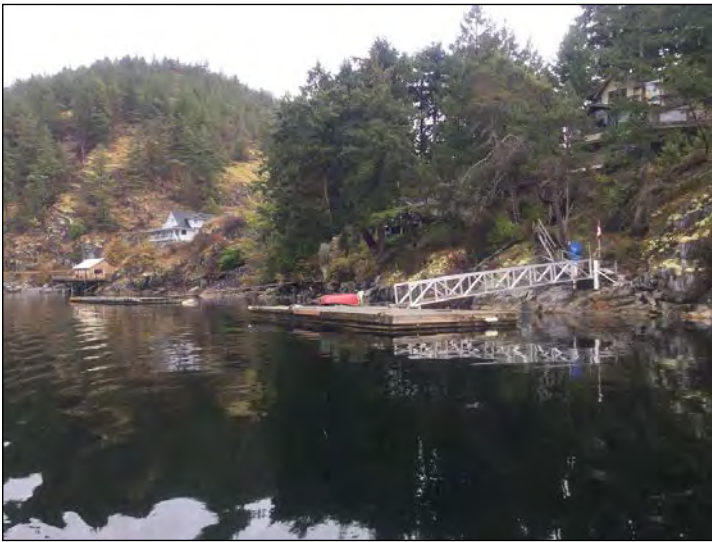
Photo: 222
Dock on Fisher Island, in Lee Bay.
(Latitude: 49°38'5.87", Longitude: -124°3'41.39", Date Taken:
October-12-17 11:03:50 AM)

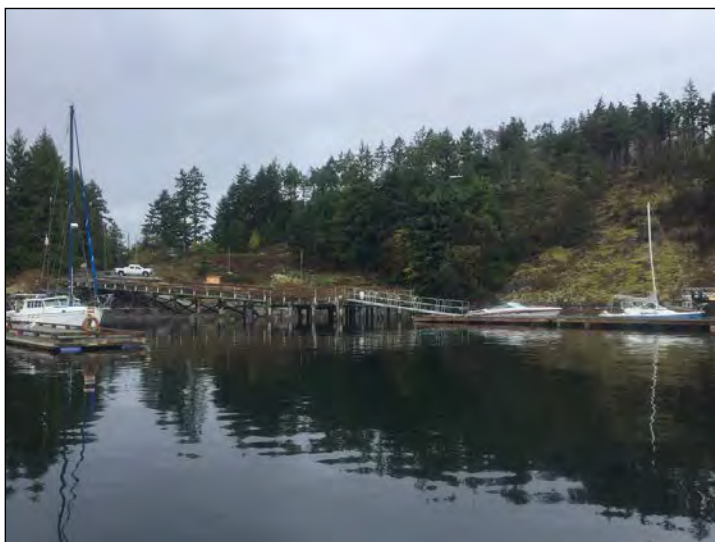
Photo: 227
Looking east into Pender Harbour from T3.
(Latitude: 49°37'51.93", Longitude: -124°3'32.11", Date Taken:
October-12-17 11:10:00 AM)

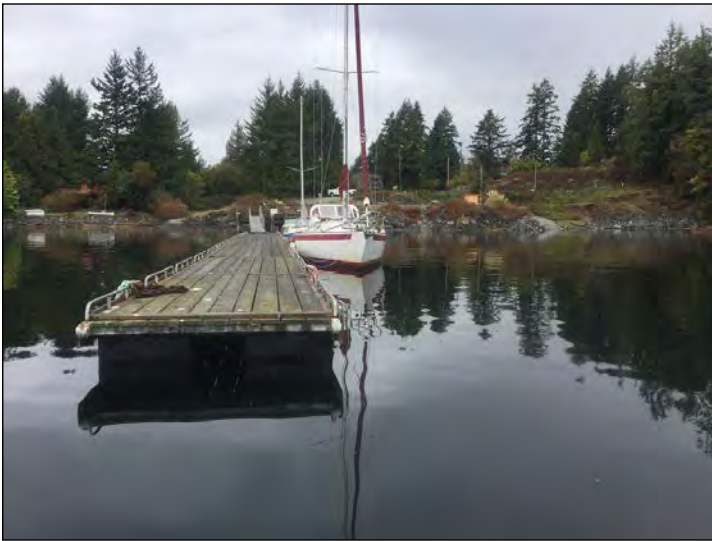
Photo: 228
Irvines Landing in Joe Bay.
(Latitude: 49°37'53.57", Longitude: -124°3'24.04", Date Taken:
October-12-17 11:12:10 AM)

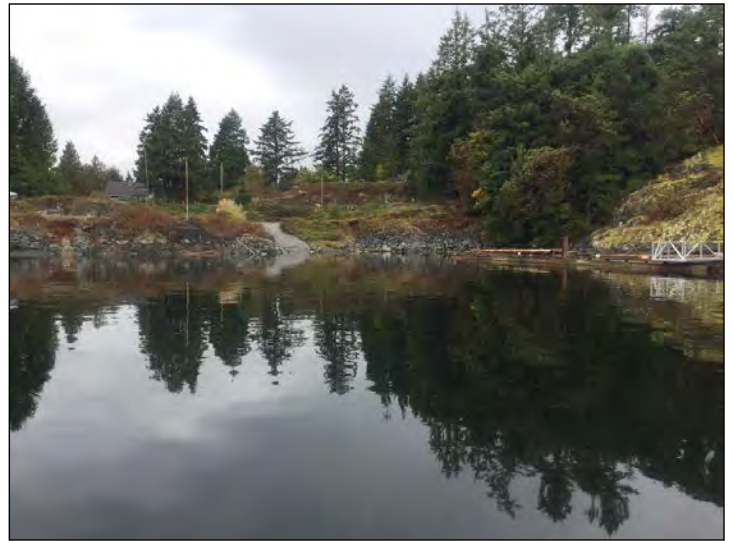
Photo: 229
Backshore of T4, Irvines Landing in Joe Bay.
(Latitude: 49°37'54.66", Longitude: -124°3'22.02", Date Taken:
October-12-17 11:12:55 AM)

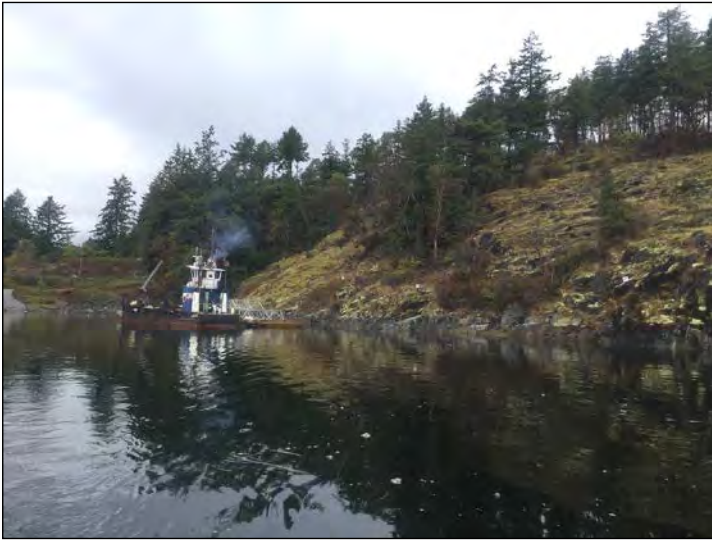
Photo: 230
Boat ramp at Irvines Landing in Joe Bay.
(Latitude: 49°37'55.77", Longitude: -124°3'22.86", Date Taken:
October-12-17 11:13:48 AM)

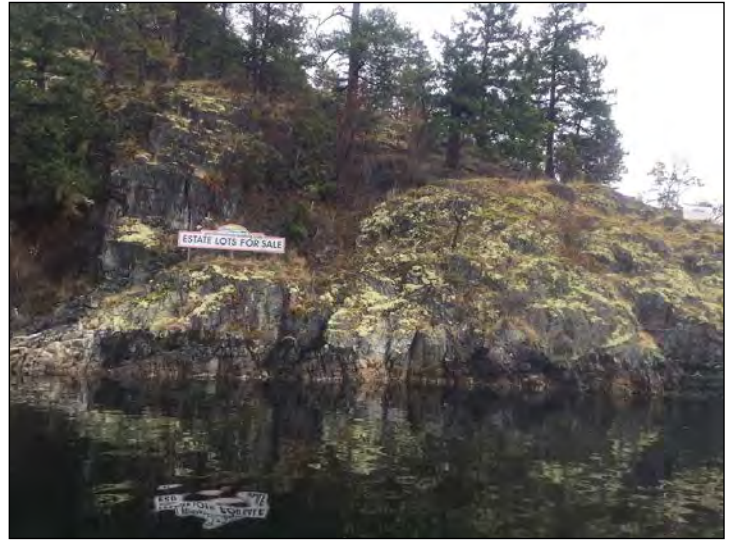
Photo: 231
Lots for sale in Joe Bay. New dock as of 2014 orthophotographs.
(Latitude: 49°37'54.97", Longitude: -124°3'19.71", Date Taken:
October-12-17 11:14:35 AM)

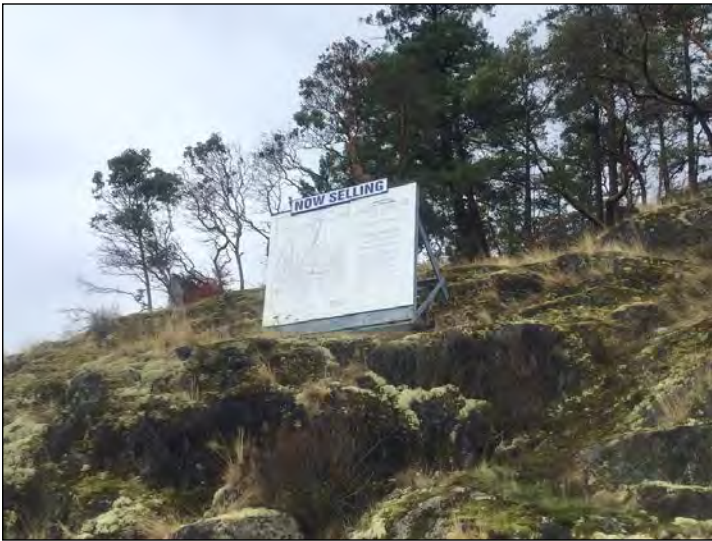
Photo: 232
Lots for sale in Joe Bay.
(Latitude: 49°37'54.09", Longitude: -124°3'17.64", Date Taken:
October-12-17 11:15:10 AM)

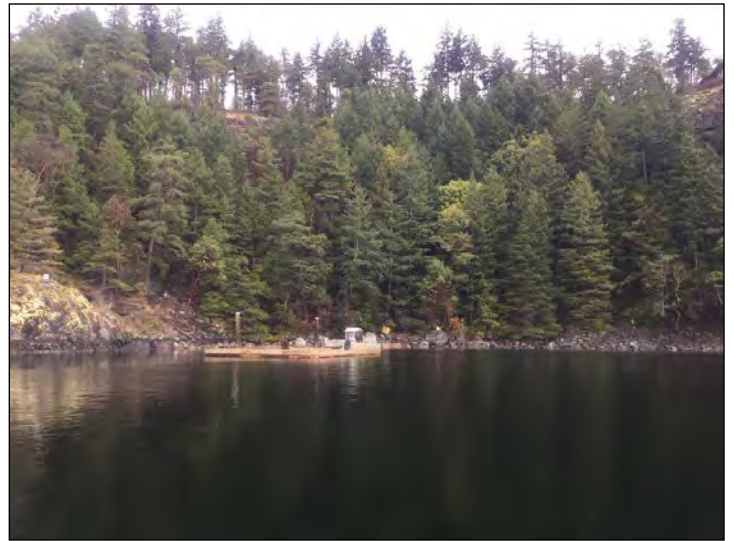
Photo: 233
Development plan sign in Bill Bay.
(Latitude: 49°37'54.69", Longitude: -124°3'13.36", Date Taken:
October-12-17 11:17:12 AM)

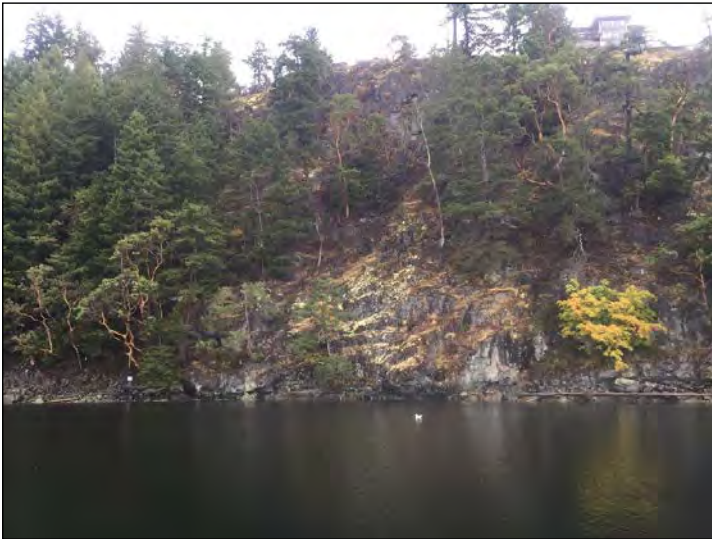
Photo: 234
Backshore of T18. Mature forest. Lots for sale along all of Bill Bay.
(Latitude: 49°37'54.29", Longitude: -124°3'10.73", Date Taken:
October-12-17 11:18:18 AM)

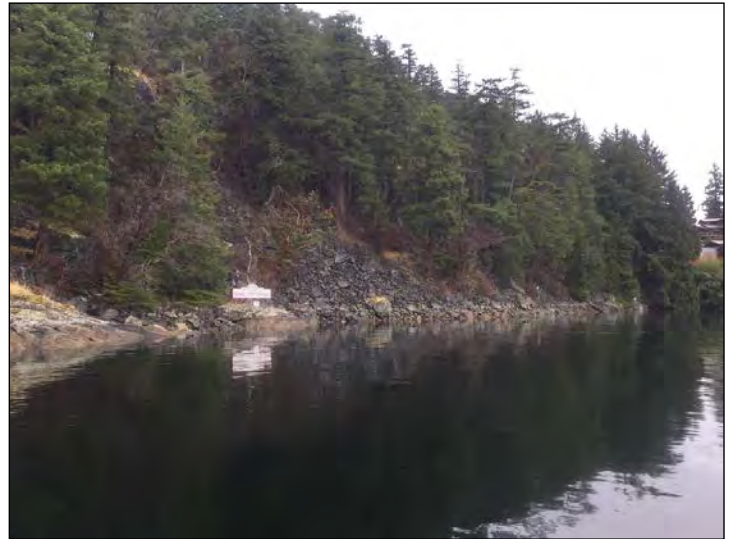
Photo: 235
Backshore of T5. Mature forest. Lots for sale along Bill Bay.
(Latitude: 49°37'54.88", Longitude: -124°3'7.76", Date Taken:
October-12-17 11:19:29 AM)

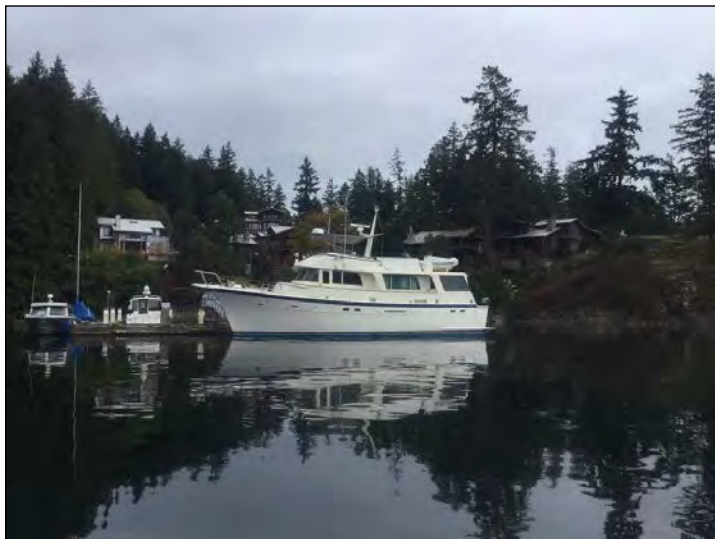
Photo: 236
Backshore of T6 along west shore of Dingman Bay. Lots for sale.
(Latitude: 49°37'54.50", Longitude: -124°3'0.79", Date Taken:
October-12-17 11:21:20 AM)

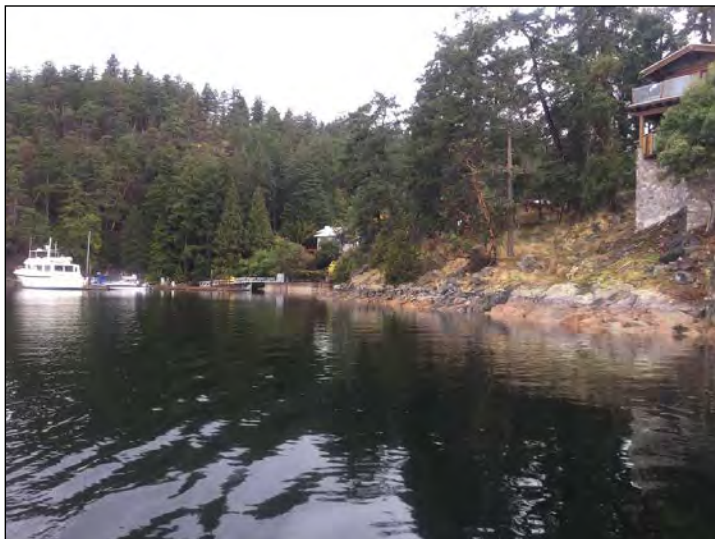
Photo: 237
East shore of Dingman Bay. Three harbour seals outside the bay.
(Latitude: 49°37'55.18", Longitude: -124°2'56.42", Date Taken:
October-12-17 11:22:10 AM)

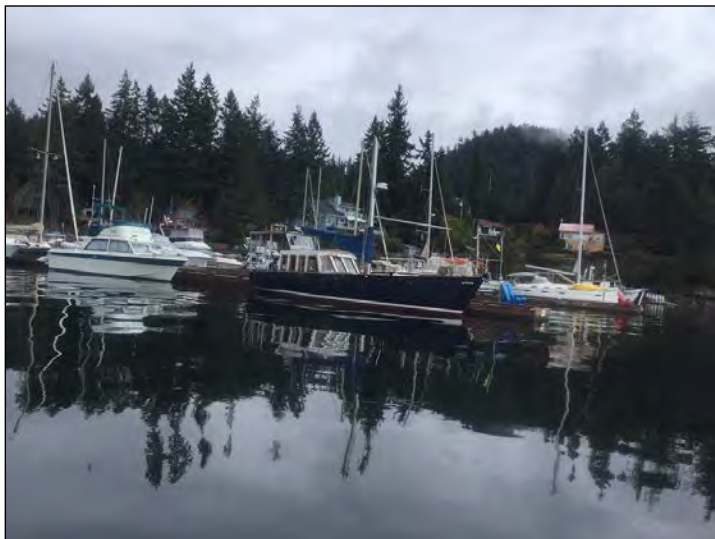
Photo: 241
West shore of Duncan Cove. Coniferous trees and arbutus trees.
(Latitude: 49°37'55.62", Longitude: -124°2'37.33", Date Taken:
October-12-17 11:26:52 AM)

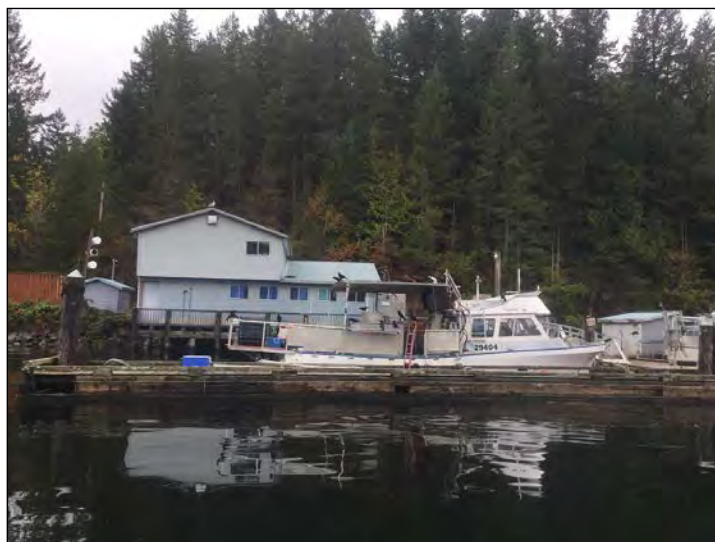
Photo: 259
 Backshore of T28. Pender Harbour Fishing Company.
 (Latitude: 49°37'37.35", Longitude: -124°2'29.08", Date Taken:
 October-12-17 1:08:19 PM)

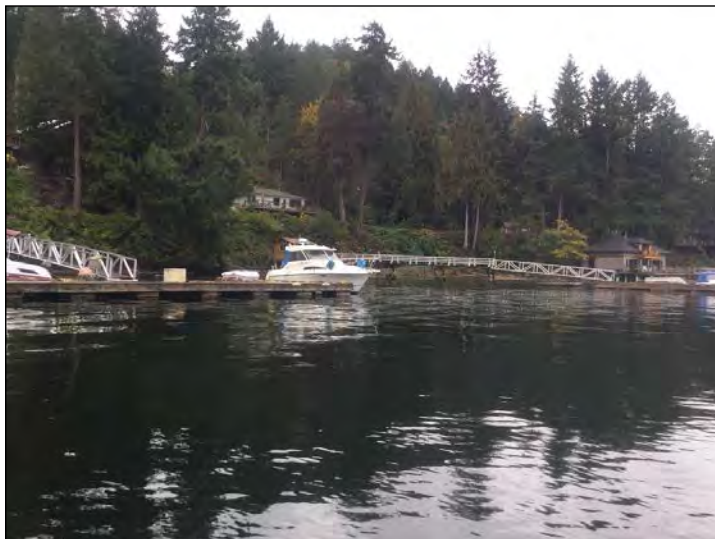
Photo: 260
 Pender Harbour Fishing Company. North shore of Francis
 Peninsula.
 (Latitude: 49°37'37.45", Longitude: -124°2'33.14", Date Taken:
 October-12-17 1:09:23 PM)

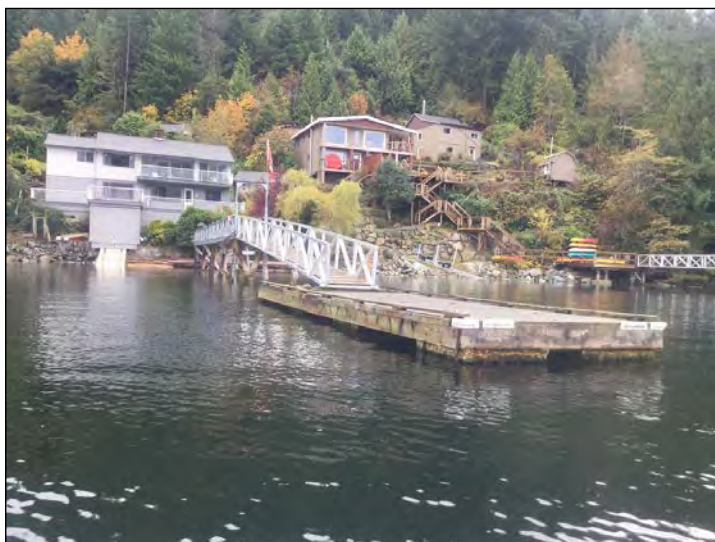
Photo: 262
North shore of Francis Peninsula. Human-altered foreshore.
(Latitude: 49°37'38.23", Longitude: -124°2'47.12", Date Taken:
October-12-17 1:12:17 PM)

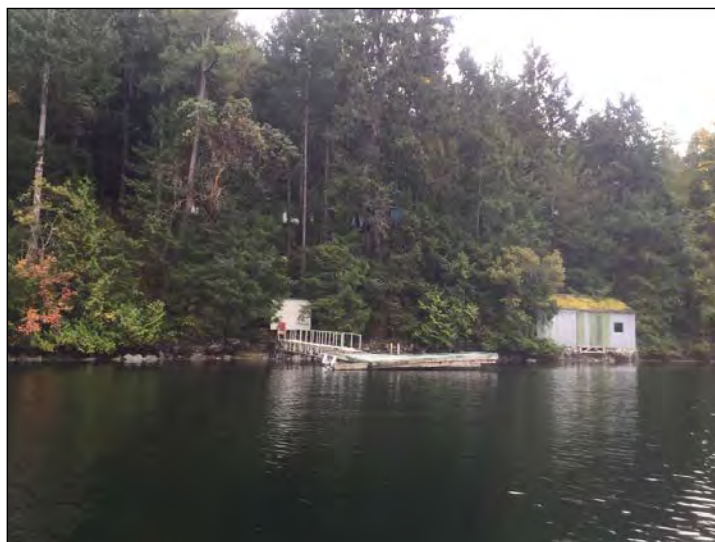
Photo: 263
Dock and private boat ramp. North shore of Francis Peninsula.
(Latitude: 49°37'37.56", Longitude: -124°2'54.49", Date Taken:
October-12-17 1:15:39 PM)

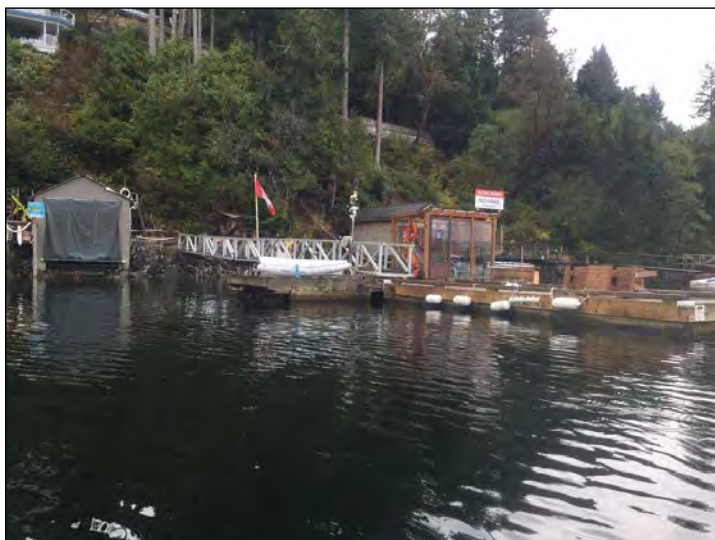
Photo: 266
Makeshift boat ramp. Dock with metal grating. North side of
Francis Peninsula.
(Latitude: 49°37'36.21", Longitude: -124°3'4.05", Date Taken:
October-12-17 1:18:20 PM)

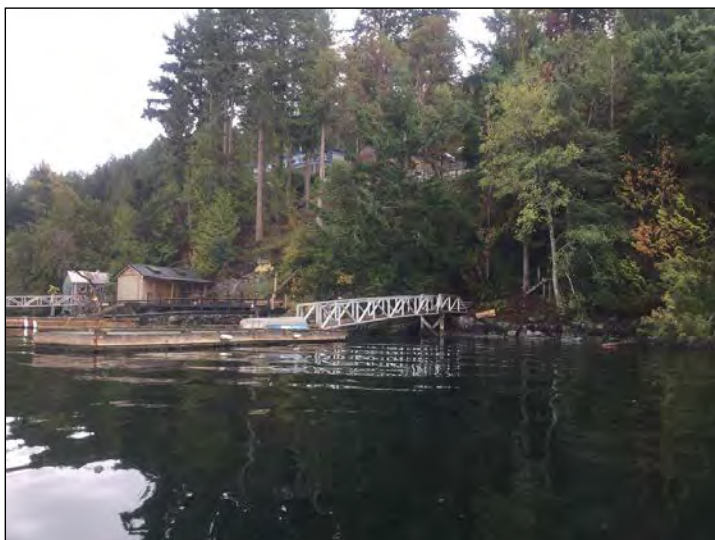
Photo: 268
North shore of Francis Peninsula.
(Latitude: 49°37'34.92", Longitude: -124°3'13.07", Date Taken:
October-12-17 1:20:57 PM)

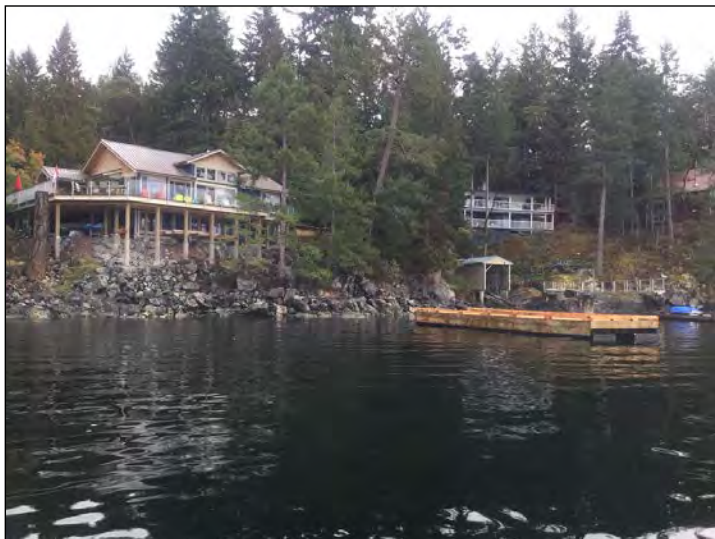
Photo: 278
New dock. Northwest shore of Francis Peninsula.
(Latitude: 49°37'26.51", Longitude: -124°3'39.89", Date Taken:
October-12-17 1:29:15 PM)

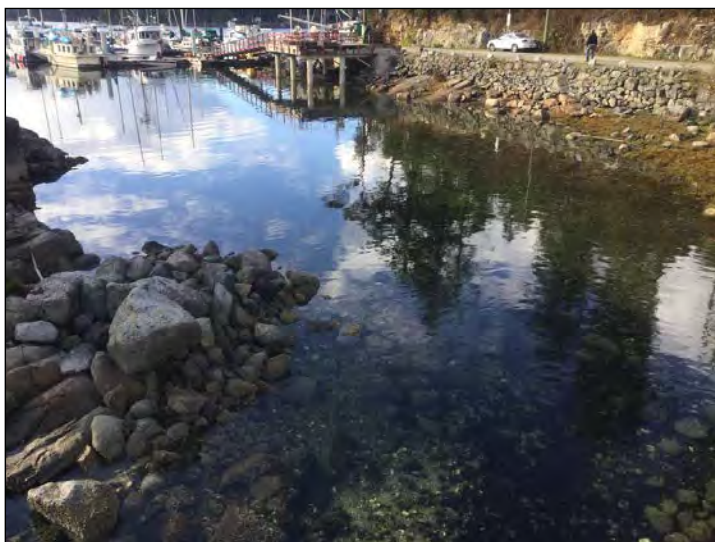
Photo: 284
Facing towards Hospital Bay from bridge. Substrate composed of
cobble, boulders, gravel. Live oysters and oyster shells along
margin of channel. Perch observed in channel. Barnacles
(Balance glandula) over rocks and patchy Fucus sp.
(Latitude: 49°37'54.98", Longitude: -124°1'49.57", Date Taken:
October-12-17 3:35:58 PM)

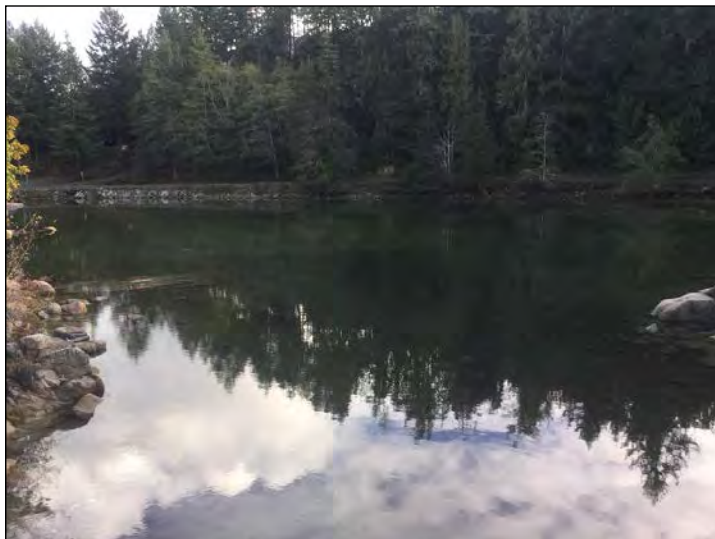
Photo: 285

Facing from bridge northeast to the pool behind John Henry's Resort. Barnacles (*Balanus glandula*) and oysters on the rocks adjacent to the bridge. Patchy *Fucus* sp. Unvegetated gravel in the pool.
(Latitude: 49°37'54.68", Longitude: -124°1'49.17", Date Taken: October-12-17 3:39:43 PM)

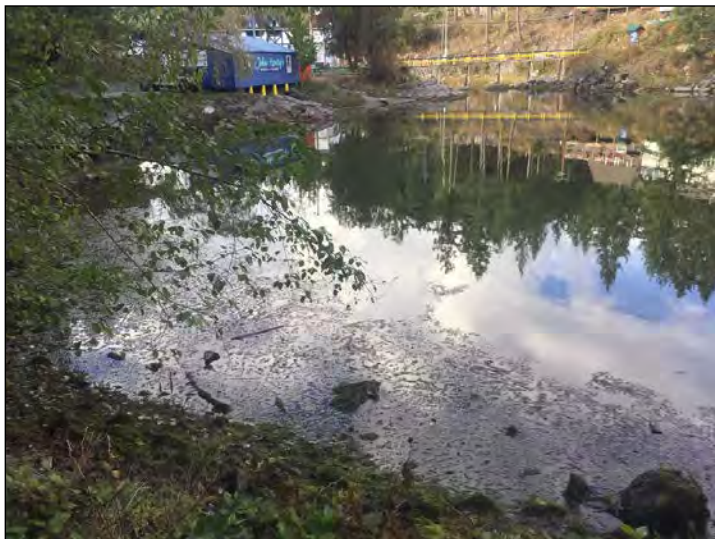
Photo: 286

Filamentous green algae covering rocks in southeast corner of pool behind John Henry's Resort. Patchy *Fucus* sp. Barnacles (*Balanus glandula*) on rocks larger than cobble.
(Latitude: 49°37'52.47", Longitude: -124°1'48.00", Date Taken: October-12-17 3:48:39 PM)

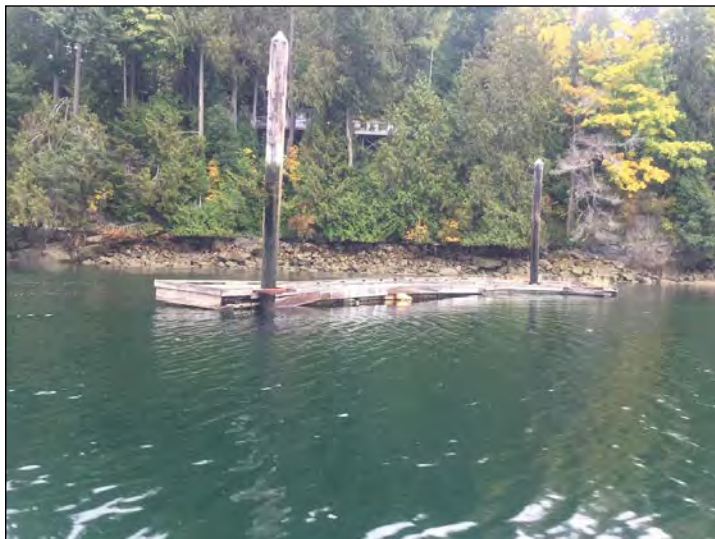
Photo: 289
Dock falling apart in southwest Gerrans Bay.
(Latitude: 49°37'0.95", Longitude: -124°2'35.73", Date Taken:
October-16-17 9:01:57 AM)

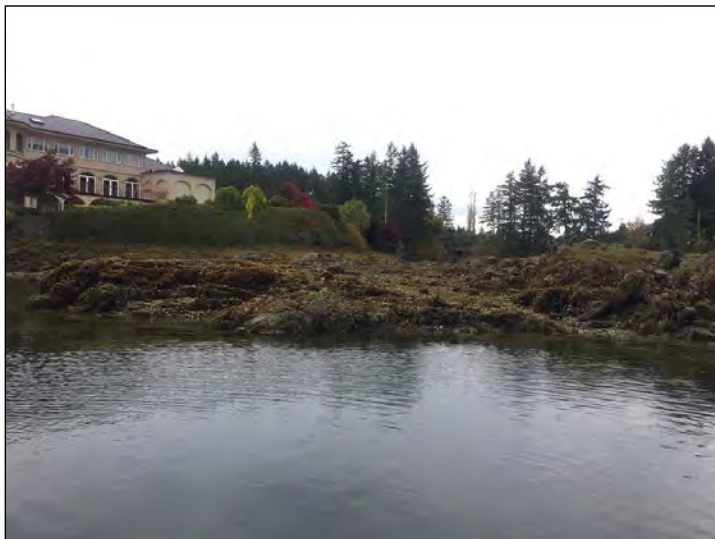
Photo: 290
Exposed high intertidal in southeast Gerrans Bay. Oysters and a few ochre stars visible.
(Latitude: 49°37'5.73", Longitude: -124°1'53.16", Date Taken:
October-16-17 11:01:00 AM)

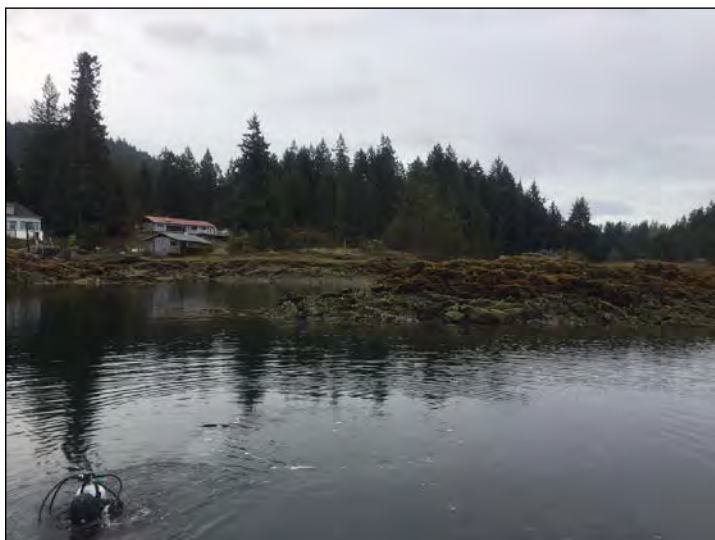
Photo: 291
Southeast end of Gerrans Bay where a channel leads to a lagoon. Fucus exposed at low tide. Blue heron in photo. Surveying for eelgrass, divers reported the substrate was mud/sand covered with thick filamentous green algae, and abundant worms. Only sparse eelgrass shoots observed.
(Latitude: 49°37'5.71", Longitude: -124°1'50.50", Date Taken:
October-16-17 11:04:32 AM)

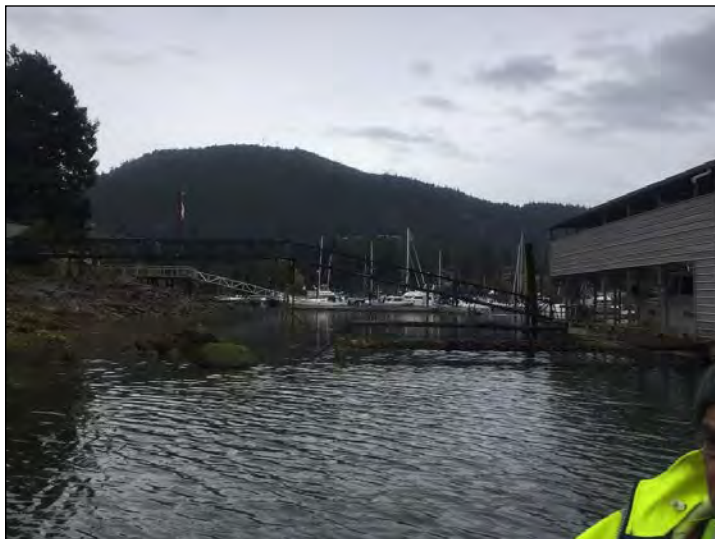
Photo: 293
A few eelgrass shoots observed to the west of Coho Marina Resort.
(Latitude: 49°37'14.50", Longitude: -124°2'1.46", Date Taken: October-16-17 11:24:33 AM)

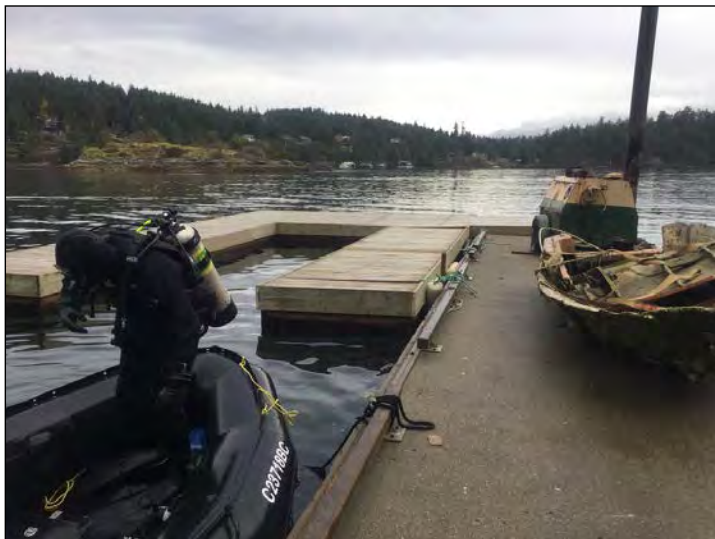
Photo: 294
Eelgrass bed delineation around T5.
(Latitude: 49°37'56.38", Longitude: -124°3'10.83", Date Taken: October-16-17 11:43:56 AM)

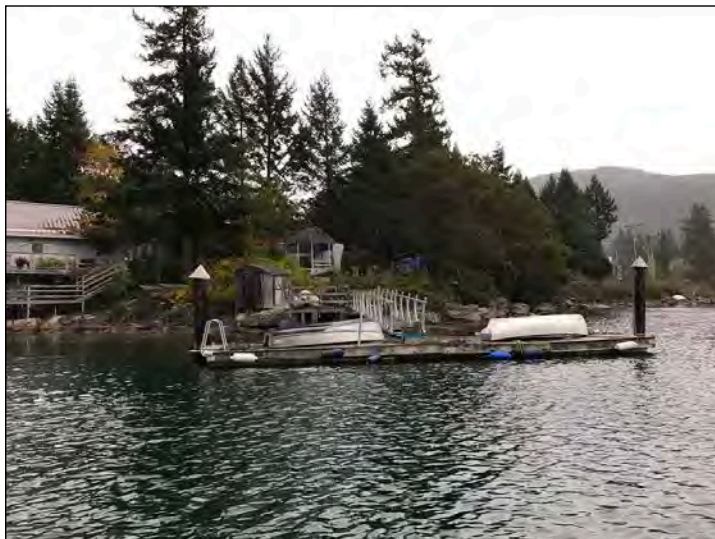
Photo: 80
Location of eelgrass transect EG3. Eelgrass growing around but not under dock. This newer dock has concrete decking with holes, and has replaced the old dock shown in 2014 orthophotographs. New dock has a larger footprint than old dock.
(Latitude: 49°36'48.50", Longitude: -124°2'28.68")

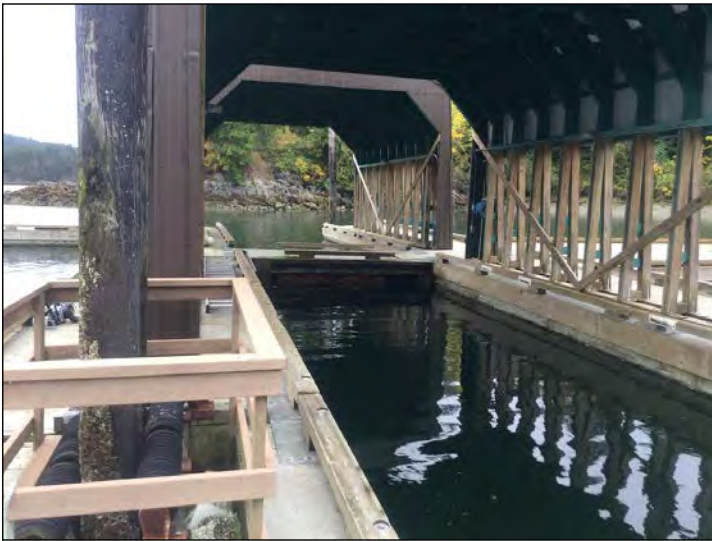
Photo: 84
Location of eelgrass transect EG2. Eelgrass growing around the dock and under end of dock. This newer dock appears to have a longer footprint than the old dock shown in 2014 orthophotographs.
(Latitude: 49°36'50.42", Longitude: -124°2'25.24")
