IMPACTS OF DOCKS IN PENDER HARBOUR: PHASE 2 ASSESSMENT

MARCH 2018

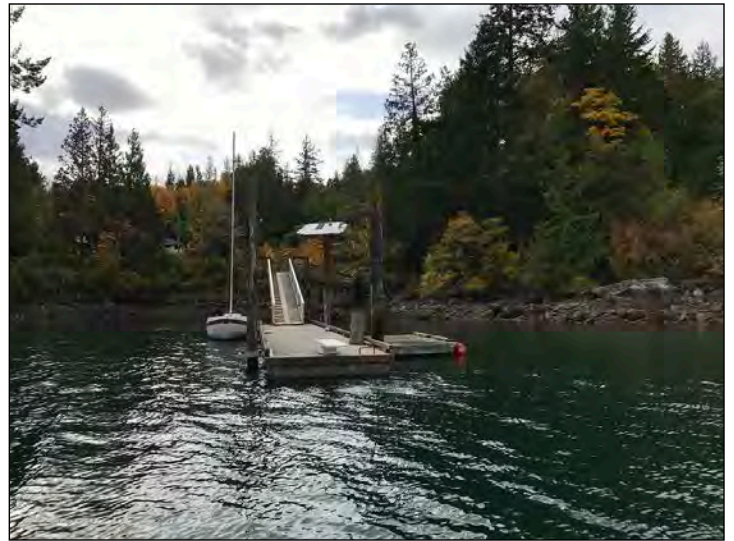
Photo: 85
 Eelgrass growing around but not under dock. Concrete deck.
 Location of eelgrass transect EG4.
 (Latitude: 49°36'39.88", Longitude: -124°2'27.17")

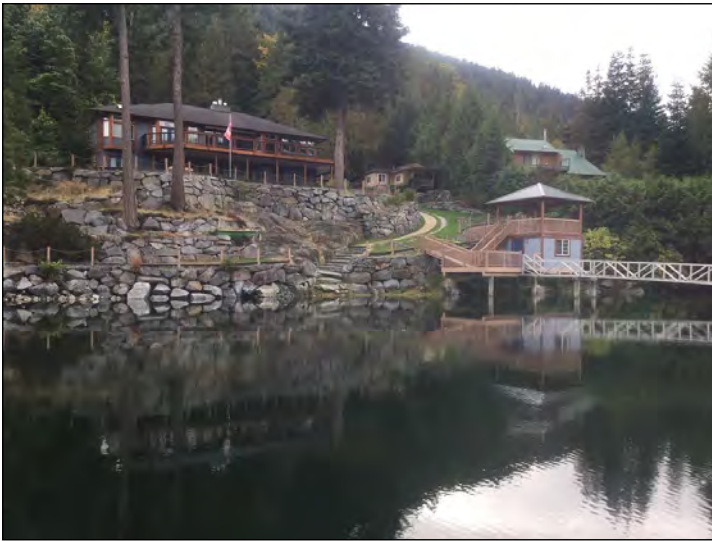
Photo: 1
South shore of Gunboat Bay. Human-altered foreshore.
(Date Taken: October-11-17 11:34:01 AM, Latitude:
49°37'36.72", Longitude: -124°0'22.39")

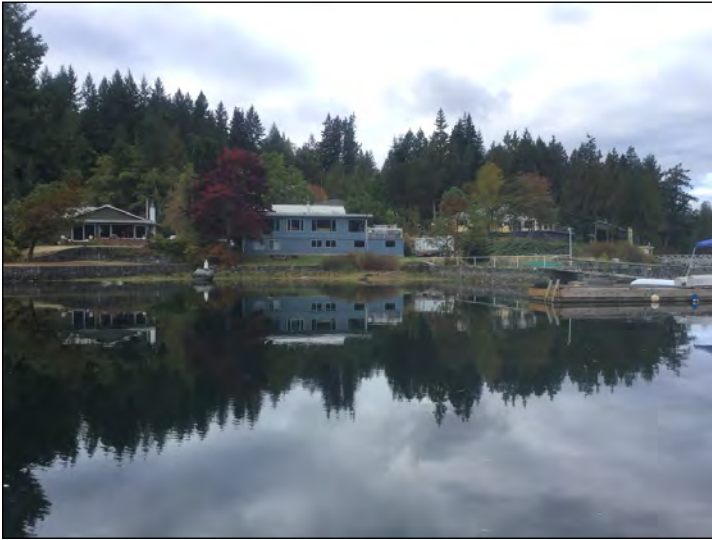
Photo: 3
South shore of Gunboat Bay. Docks and human-altered shoreline.
(Date Taken: October-11-17 11:41:02 AM, Latitude:
49°37'36.89", Longitude: -124°0'35.75")

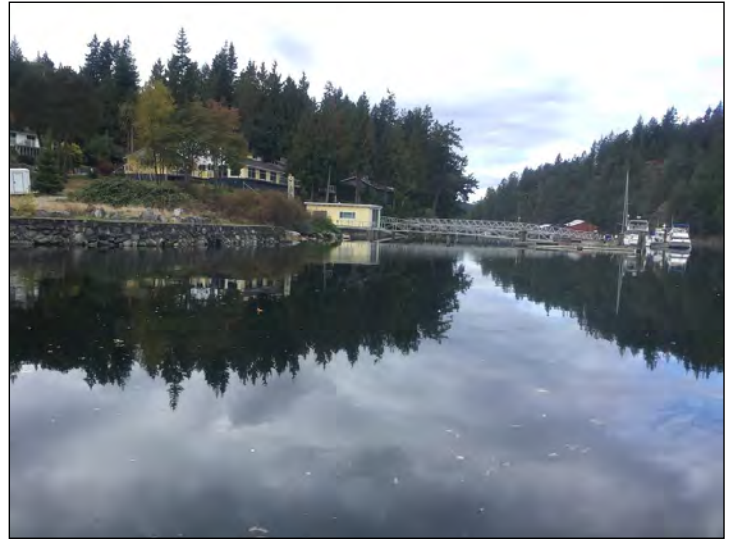
Photo: 4
South shore of Gunboat Bay. Docks and human-altered foreshore.
(Date Taken: October-11-17 11:41:35 AM, Latitude:
49°37'37.46", Longitude: -124°0'37.66")

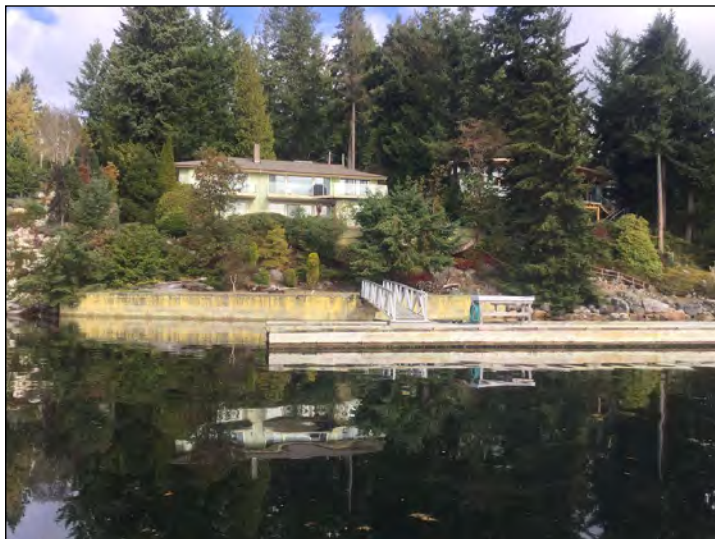
Photo: 5
Garden Peninsula shoreline between Hospital Bay and Garden Bay. Human-altered foreshore.
(Date Taken: October-11-17 12:27:20 PM, Latitude: 49°37'38.32", Longitude: -124°1'46.43")

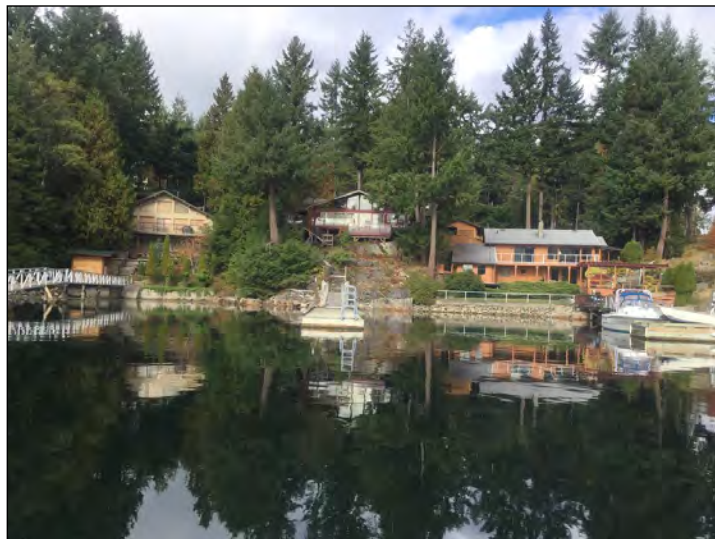
Photo: 6
Garden Peninsula shoreline between Hospital Bay and Garden Bay. Human-altered foreshore.
(Date Taken: October-11-17 12:30:14 PM, Latitude: 49°37'40.65", Longitude: -124°1'37.79")

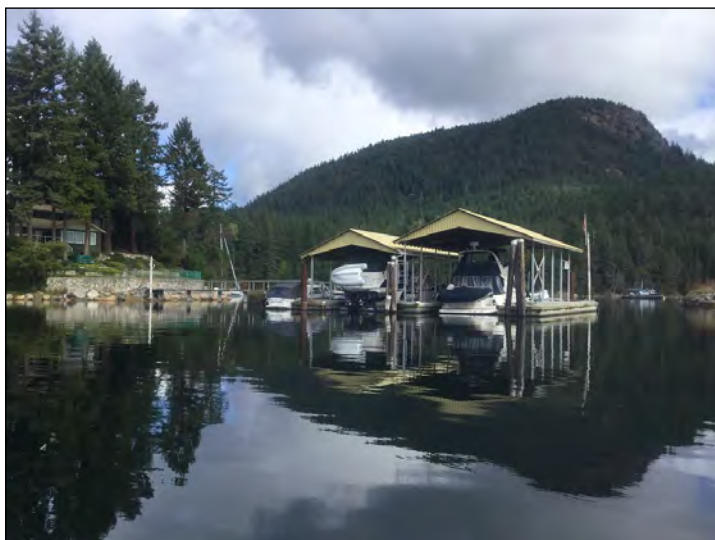
Photo: 7
Garden Peninsula shoreline between Hospital Bay and Garden Bay. Human-altered foreshore.
(Date Taken: October-11-17 12:31:56 PM, Latitude: 49°37'41.76", Longitude: -124°1'30.88")

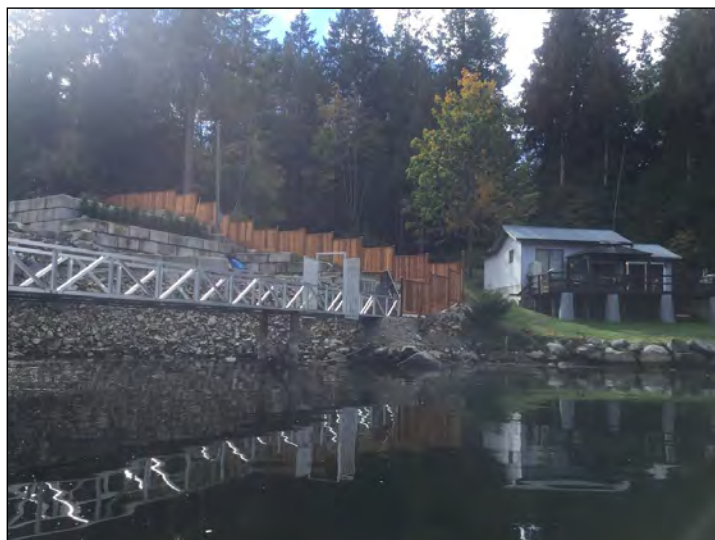
Photo: 8
Welbourn Cove. Human-altered shoreline.
(Date Taken: October-11-17 1:23:39 PM, Latitude: 49°37'23.10", Longitude: -124°1'40.74")

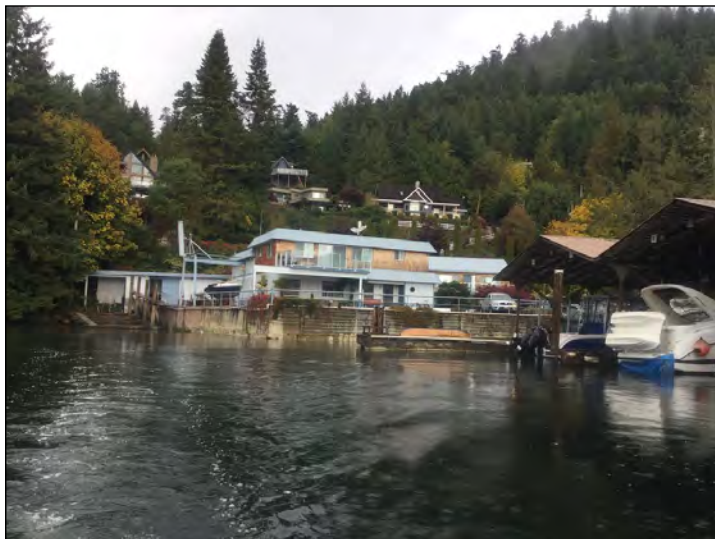
Photo: 9
Northwest end of Hospital Bay. Human-altered foreshore.
(Date Taken: October-12-17 11:42:37 AM, Latitude: 49°38'5.43", Longitude: -124°2'16.90")

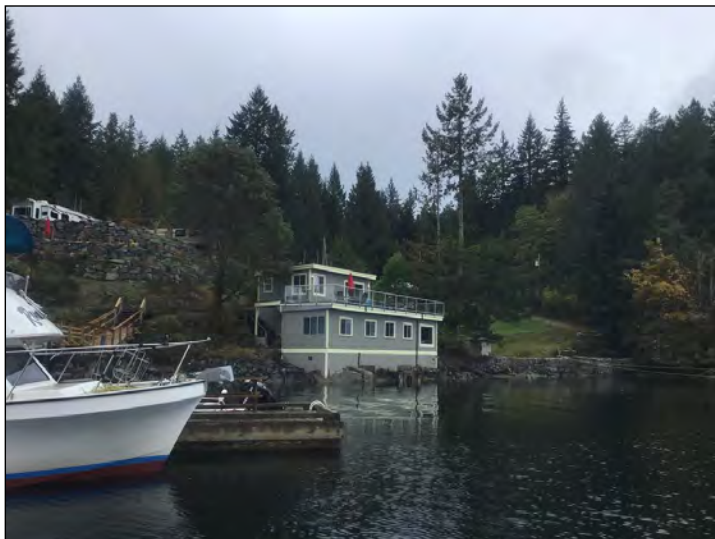
Photo: 10
Backshore east of T28. Human-altered foreshore.
(Date Taken: October-12-17 1:07:50 PM, Latitude: 49°37'37.32", Longitude: -124°2'28.80")

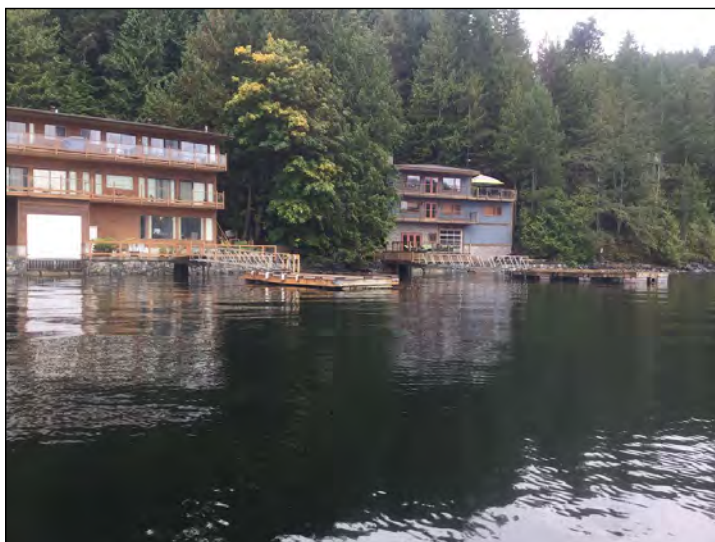
Photo: 11
North shore of Francis Peninsula. Human-altered foreshore.
(Date Taken: October-12-17 1:10:40 PM, Latitude: 49°37'37.59", Longitude: -124°2'39.19")

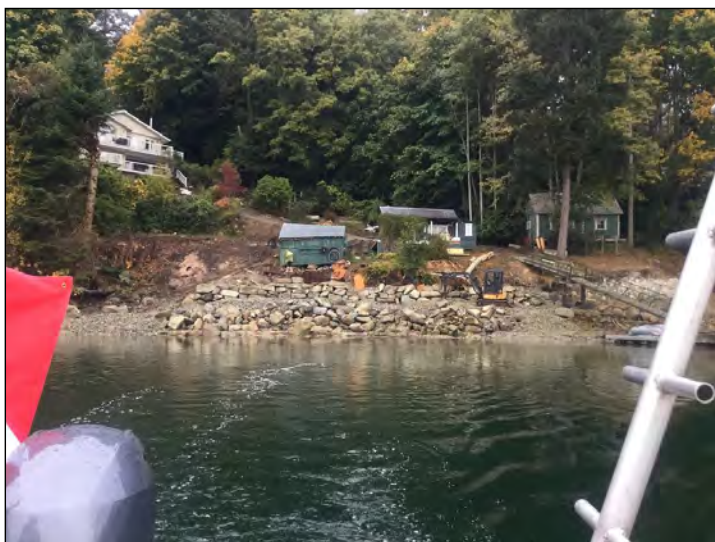
Photo: 12
West shore of Gerrans Bay. Human-altered foreshore.
(Date Taken: October-16-17 8:56:40 AM, Latitude: 49°37'12.01", Longitude: -124°2'37.42")

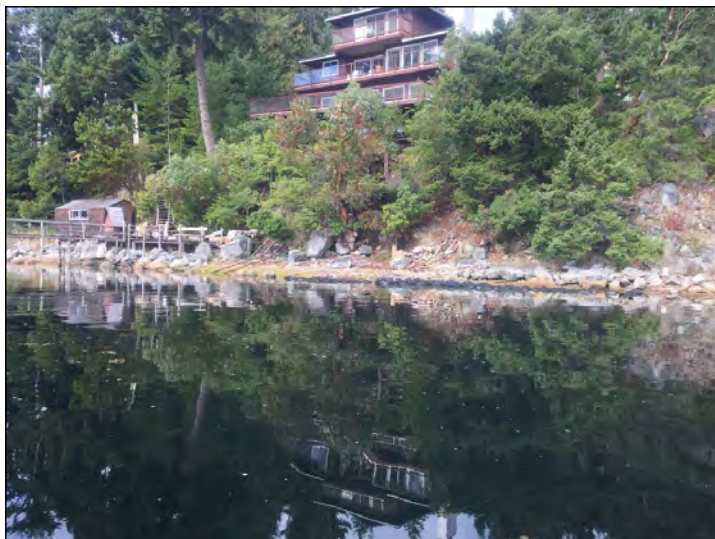
Photo: 1
Garden Peninsula shoreline between Hospital Bay and Garden Bay. Tires strung together in intertidal zone.
(Date Taken: October-11-17 12:28:46 PM, Latitude: 49°37'38.73", Longitude: -124°1'41.23")

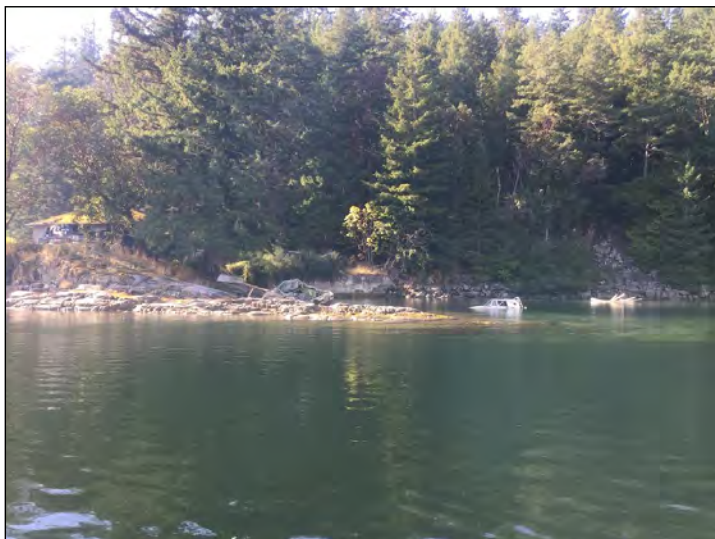
Photo: 2
Sunken boats along west shore of Gerrans Bay.
(Date Taken: October-11-17 2:16:39 PM, Latitude: 49°37'19.08", Longitude: -124°2'30.60")

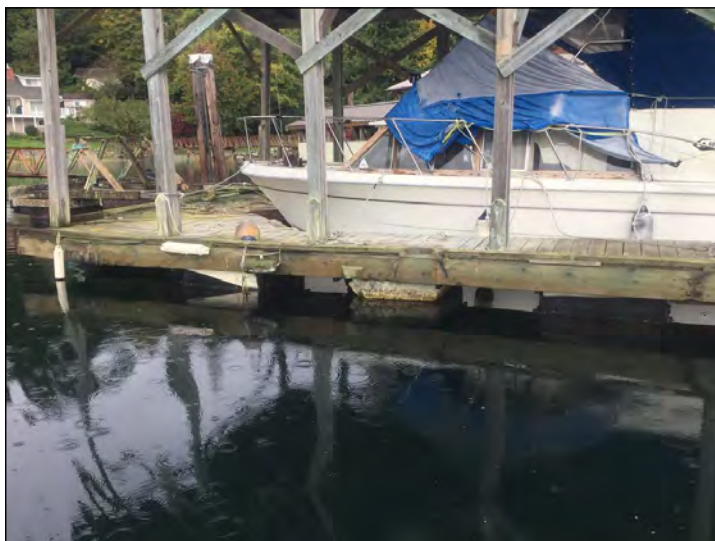
Photo: 3
Old dock with plastic casing falling off styrofoam floats.
(Date Taken: October-12-17 11:40:45 AM, Latitude: 49°38'4.42", Longitude: -124°2'17.82")

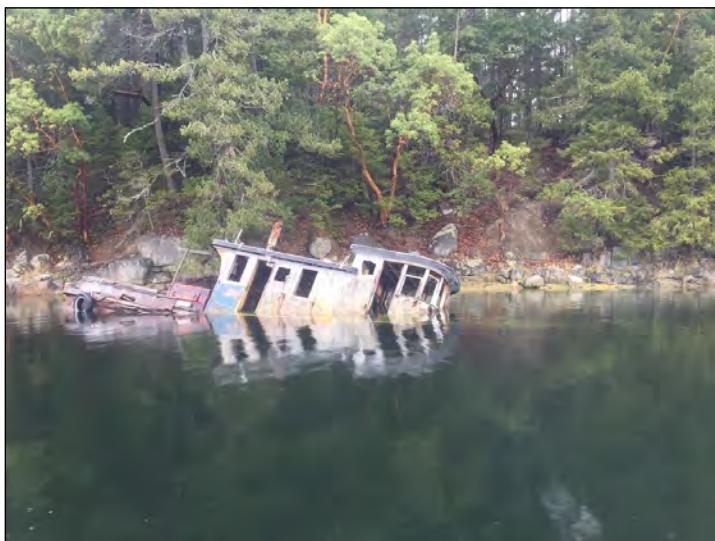
Photo: 4
Sunken tug boat at south end of Dusenbury Island.
(Date Taken: October-12-17 12:59:34 PM, Latitude: 49°37'15.25", Longitude: -124°2'22.02")

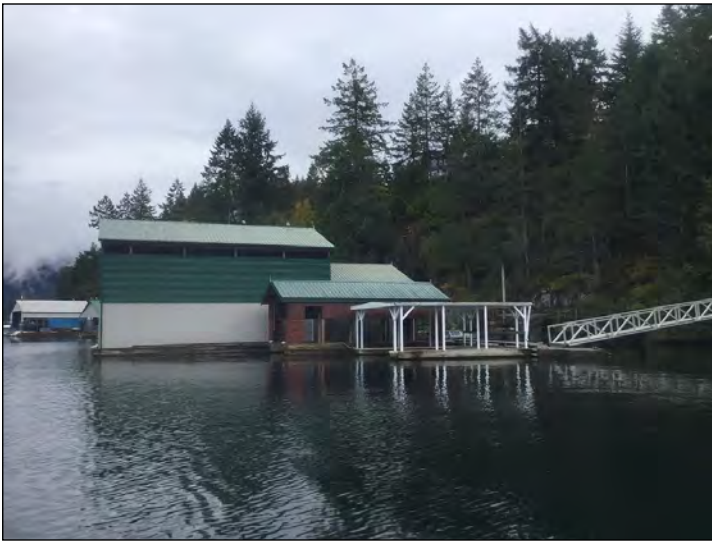
Photo: 5
Boathouses and docks shade subtidal habitats. North shore of Francis Peninsula.
(Date Taken: October-12-17 1:25:00 PM, Latitude: 49°37'30.58", Longitude: -124°3'25.90")
